Rattling or Squeaking Noises In the Area of the Rear Lid: Check Adjustment of Guide Wedges and, If Necessary, Rear Lid Lock (62/24)

Model Line: **Cayenne (9YA / 9YB)**

Model Year: **As of 2024**

Concerns: **Upper part of rear lid lock (rear lid lock)**

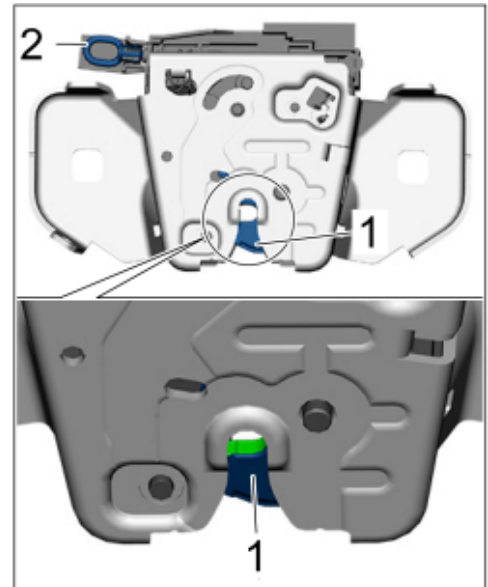
Rear lid lock (example illustration)

- 1.1 Lock catch hook ⇒ -1- in the **catching position**
⇒ -Circle-shown.

Work Procedure: 1 Apply grease to catch hook.
