Rattling or Squeaking Noises In the Area of the Rear Lid: Check Adjustment of Guide Wedges and, If Necessary, Rear Lid Lock (62/24)

Model Line: **Macan (XAB)**

Model Year: **As of 2024**

Concerns: **Upper part of rear lid lock (rear lid lock)**

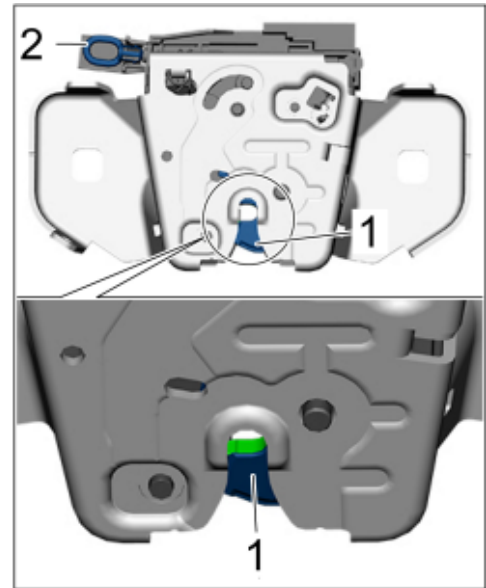
Rear lid lock (example illustration)

- 1.1 Lock catch hook ⇒ *Rear lid lock (example illustration) -1-* in the **catching position** ⇒ *Rear lid lock (example illustration) -Circle-* shown.

Work Procedure: 1 Apply grease to catch hook.
