Bulletin #: 2518.1

# Y1A, Y1B, Y1C- High-Voltage (HV) Battery Measurements during HV Battery Repair

Models	Model Year	Model Type	VIN Range	Vehicle-Specific Equipment
ſ	Taycan	As of 2020 up to 2024	Y1A, Y1B, Y1C	All	N/A

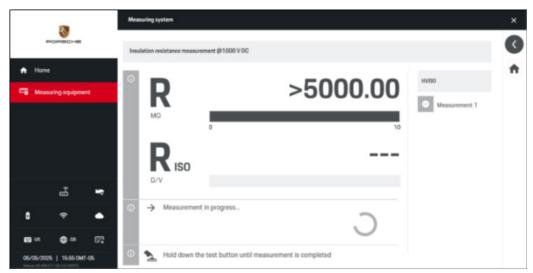
Figure 5 - Insulation resistance measurement in PIWIS Tester

- Shown below is an example of passing test result of >5000 M $\Omega$ . This is the reading when IR measures above the 500 MOhm measuring threshold.
- If the first IR test on either module terminal fails, but the second one passes, the module is okay and should not be replaced.
- If any second terminal IR test shows a number below 500 M $\Omega$ , this is considered a failure.
- Document any failures in the "Module insulation Resistance Template" Excel file attachment and attach to the PRMS Ticket and repair PCSS entry.
