Checking Dual-Mass Flywheel (DMF) on Vehicles with PDK (11/14)

Model Line: **Panamera (970)/ Panamera (971)/ Panamera (YAA/YAB)**
911 Carrera (991)/ 911 Carrera (992)
Boxster (981)/ Boxster (982)
Cayman (981)/ Cayman (982)

Concerns: **Dual-mass flywheel (DMF)**

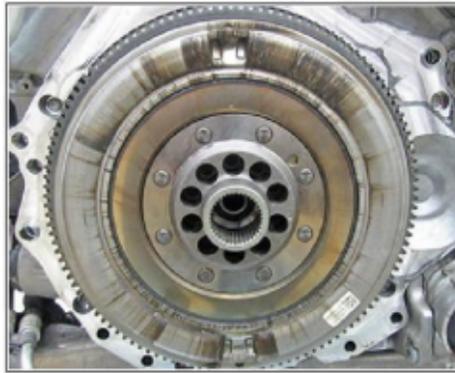
Figure 1

A small amount of grease is leaking out:

A small amount of grease is leaking out of the dual-mass flywheel ⇒ *Figure 1* and there is a ring of grease in the clutch housing ⇒ *Figure 2*.

Grease leaking from the dual-mass flywheel is function-related and does not result in function restrictions, noises or vibrations. The grease leak may be due to vibrations caused by a rough-running engine, for example.

⇒ **Replacement of the dual-mass flywheel is not justified.**

⇒ **Remove grease and clean the clutch housing.**

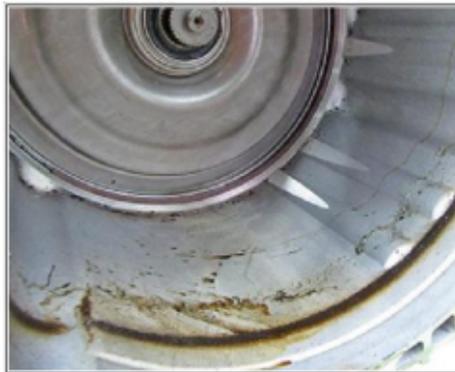
Figure 2

A ring of grease as shown in *Figure 2* is considered acceptable and does not justify replacing the dual-mass flywheel. More dynamic driving can cause grease to leak out like this. After removing this excess emerging grease, it is unlikely that it will happen again. For this reason, we do not recommend that you install a new part. However, the dual-mass flywheel must be checked based on the other inspection criteria listed in this assessment in order to determine whether it needs to be replaced.

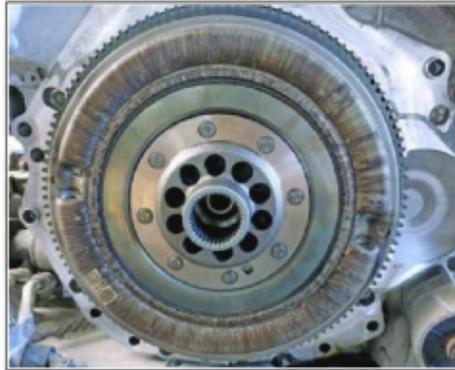
Figure 3

A large amount of grease is leaking out:

A large amount of grease is leaking out of the dual-mass flywheel ⇒ *Figure 3* and there is a full ring of grease in the clutch housing ⇒ *Figure 4*.

Function not OK

⇒ **Replacement of the dual-mass flywheel is justified.**

⇒ **Remove grease and clean the clutch housing.**

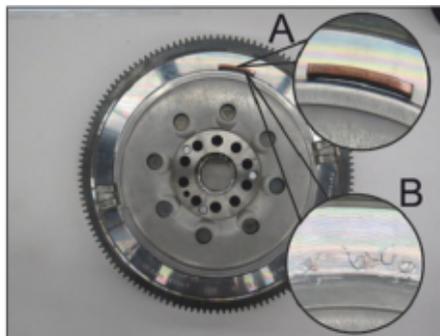
Balancing weight missing:

A balancing weight is missing and only the bonding points are left ⇒ Figure 5 .

⇒ Replacement of the dual-mass flywheel is justified.

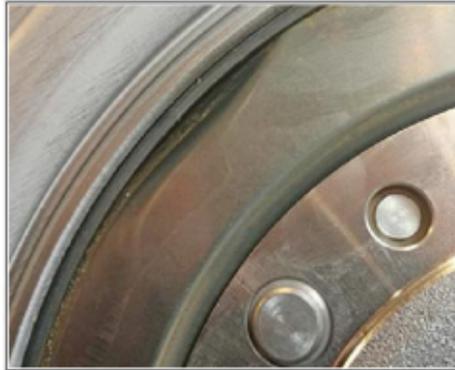
Cup spring diaphragm damaged:

The cup spring diaphragm is damaged ⇒ Figure 6 .

Damage to the cup spring diaphragm occurs as a result of improper removal of the transmission (tilting).

⇒ Replacement of the dual-mass flywheel is justified.

⇒ **Make sure not to tilt the transmission during removal.**

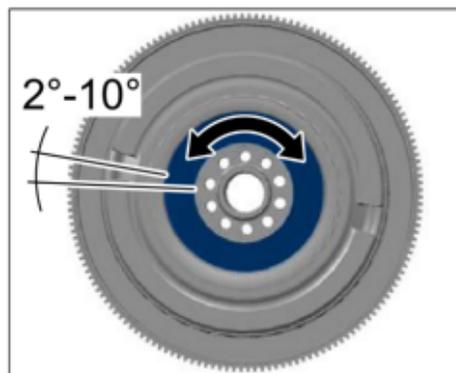
Figure 7

Flange can be turned:

The flange must turn torsionally, but must not turn back automatically.

The possible turning angle (clearance angle) is approx. $2^\circ - 10^\circ$ ⇒ Figure 7.

⇒ **Replacement of the dual-mass flywheel is not justified.**

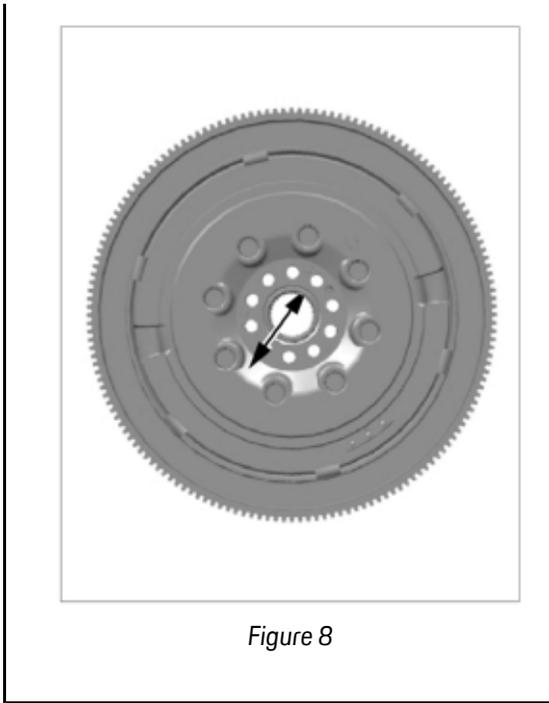
Figure 8

Flange can be moved:

The flange must move radially/axially ⇒ Figure 8.

This property is required for the PDK transmission and is used for compensation in the event of a static offset between engine and transmission.

⇒ **Replacement of the dual-mass flywheel is not justified.**
