The Front Display and Control Panel Flickers or Fails Intermittently (221/24)

Model Year: **2025**

Model Line: **Taycan (Y1A / Y1B / Y1C)**

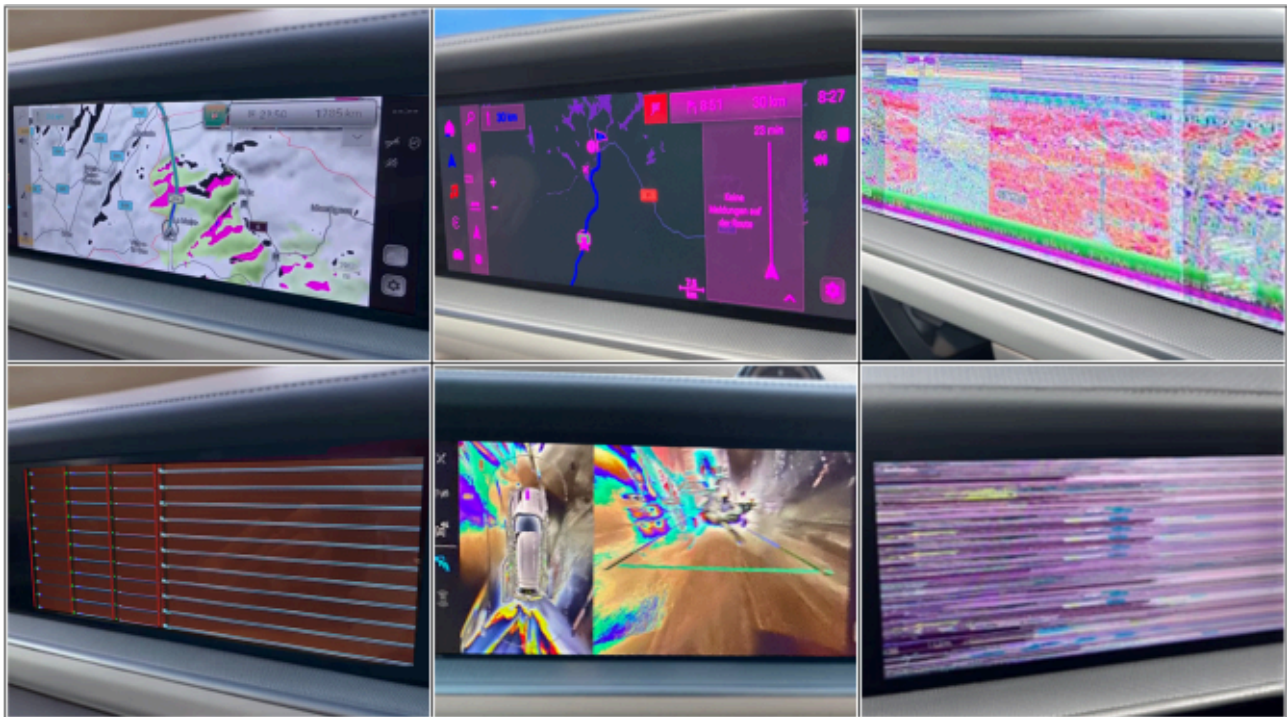
Cause: **The customer complains that the front display and control panel is flickering, fails occasionally or content is displayed in a distorted/divided manner.**

Example illustrations of complaints regarding the front display and control panel

Action: In the event of a customer complaint, re-programme the control unit for the PCM central computer (central display and passenger display) using the PIWIS Tester.
