<p>TO: Mercedes-Benz Dealer Principals, General Managers, Sales Managers, Service Managers, Parts Managers</p>	<p>FROM: Teresa Clemmer, Senior Manager – Warranty, Gregory Gunther - Senior Manager, Vehicle Compliance and Analysis, Engineering Services</p>
<p>RE: Extended Warranty – EVA2 HV AC Compressor MY2022 – 2026 EQE, EQS vehicles</p>	<p>DATE: December 05, 2025</p>

IMPORTANT EXTENDED WARRANTY INFORMATION

Extended Warranty Bulletin

CAMPAIGN NO.	Extended Warranty
SUBJECT	EVA2 High-Voltage AC Compressor
MODEL(S)	EQE and EQS (294, 295, 296 & 297 platform)
MODEL YEAR(S)	2022 – 2026
CAMPAIGN POPULATION	29,190

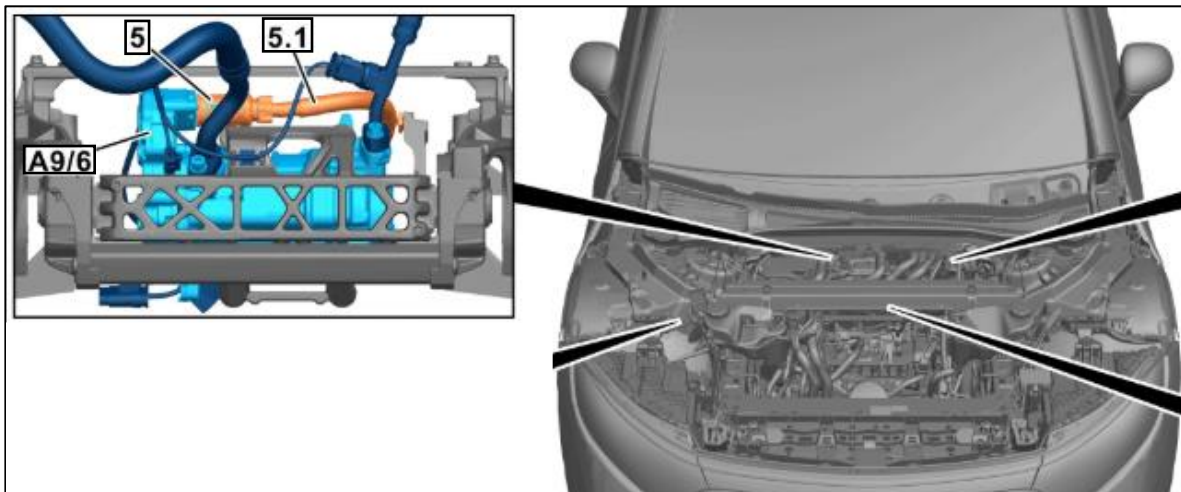
14. Remove high-voltage plug (5) and high-voltage electrical line (5.1) from refrigerant compressor (A9/6).

Shown on model 297 without code M005 (vehicles with 4MATIC/all-wheel drive)

15. Attach test adapter to refrigerant compressor (A9/6).

16. Set insulation resistance meter to 500 V and perform insulation resistance measurements (A, B).
