Surround View Static Calibration – Explanation of Debug Screen

Bulletin #: 2531

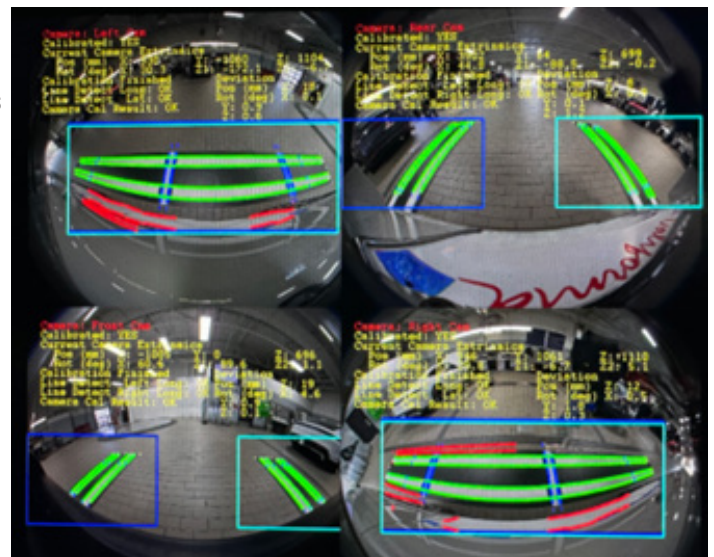
Technicians find the Surround View (Real Top View (RTV)) camera calibration is unsuccessful during diagnosis or repair of an affected vehicle. The contents of the PCM display "Debug Screen" (*Figure 1*) for calibration of the surround view cameras is unclear.

- **Yellow text** means the values are OK
- **Red text** means the values are Not OK
- **Green lines** must be aligned lengthwise (longitudinally) with the lines on the calibration mat and completely highlighted (*yellow ovals in Figure 1 and Figure 3 indicate where the green lines are not completely highlighted*)

If the surround view / top view camera calibration is unsuccessful, check the PCM display "debug screen" during a calibration attempt for information about why the calibration failed.

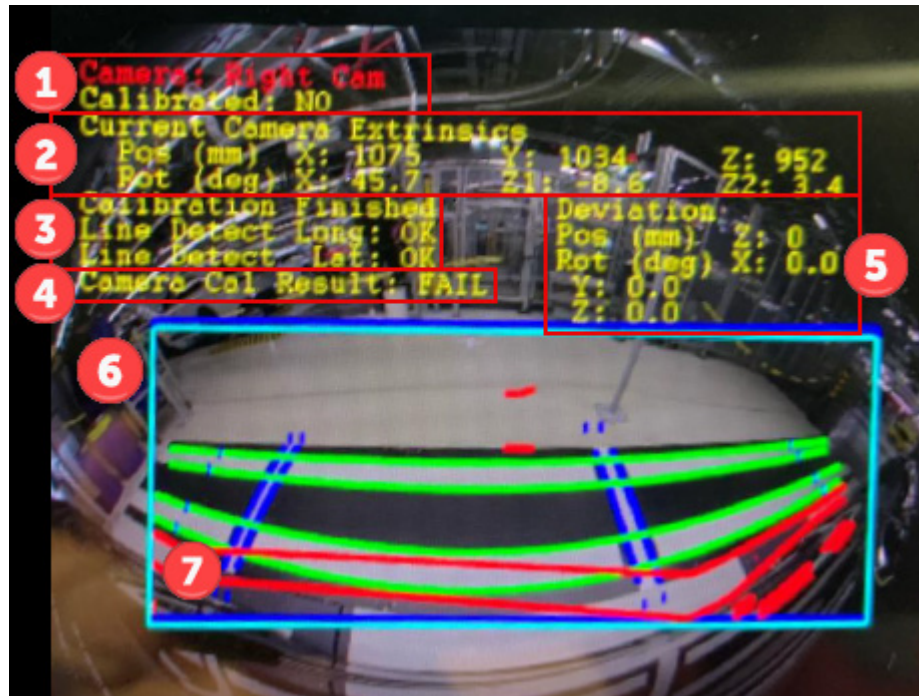
Figure 2

1. Information on whether or not the system has ever been calibrated.
2. Camera nominal position according to data set specification (X; Y; Z)
3. Information on whether the calibration process was completed, and whether or not the green longitudinal lines and blue transverse lines of the calibration target were detected
4. Information on whether the calibration result is OK or not OK (FAIL).
5. Specification of the calculated correction values based on the completed calibration process.
6. Region of interest marked in box (turquoise and blue)
7. Lines shown in red were detected but not used for calibration.

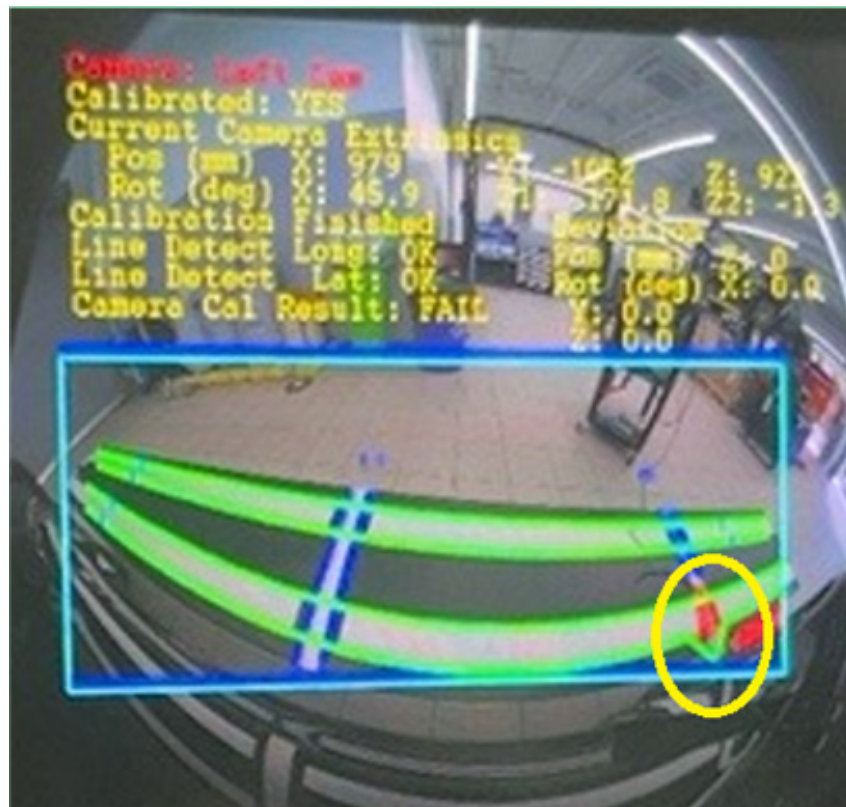
- **Blue lines** must be aligned crosswise (transversely) with the lines on the calibration mat and completely highlighted (*yellow oval in Figure 4 indicates where the blue lines are not completely highlighted*)

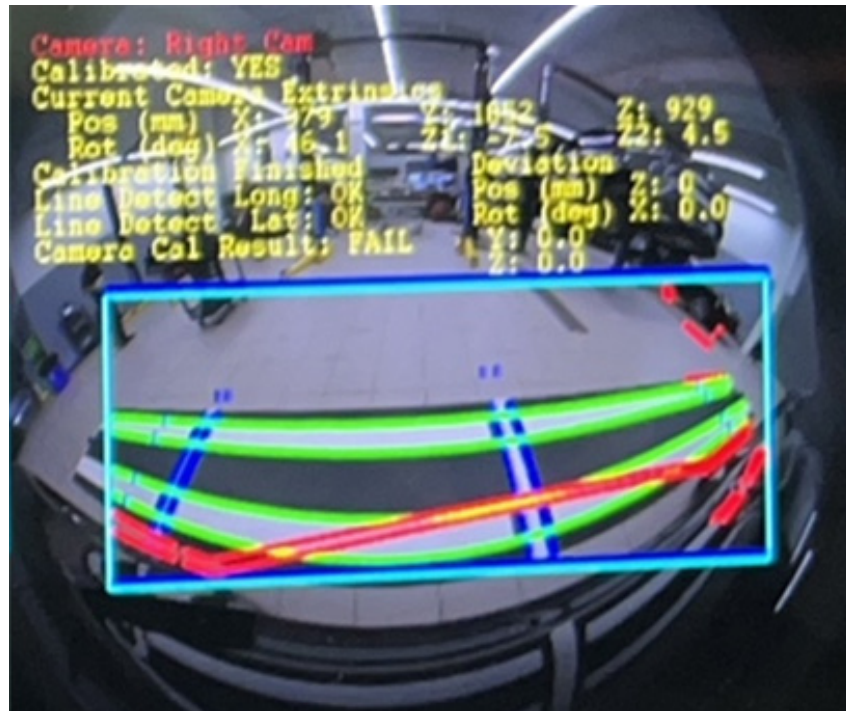
Figure 5

- **Red lines** are not used for calibration and can be ignored (*for example, red lines in Figure 5*)
- Calibration mats must be within the **Blue and Turquoise boxes** (*yellow oval in Figure 6 indicates where the calibration mat is outside the blue and turquoise boxes*)
