Field campaign

Topic	Software Update BiL 5.3.1 v1 to v2 Flying Spur 25MY (SC25/11)
Market area	Bentley: worldwide (2WBE),China 796 VW Import Comp. Ltd (Vico), Beijing (6796)
Brand	Bentley
Transaction No.	2077583/7
Campaign number	ED42
Note	
Type	
US code

25MY Flying Spur

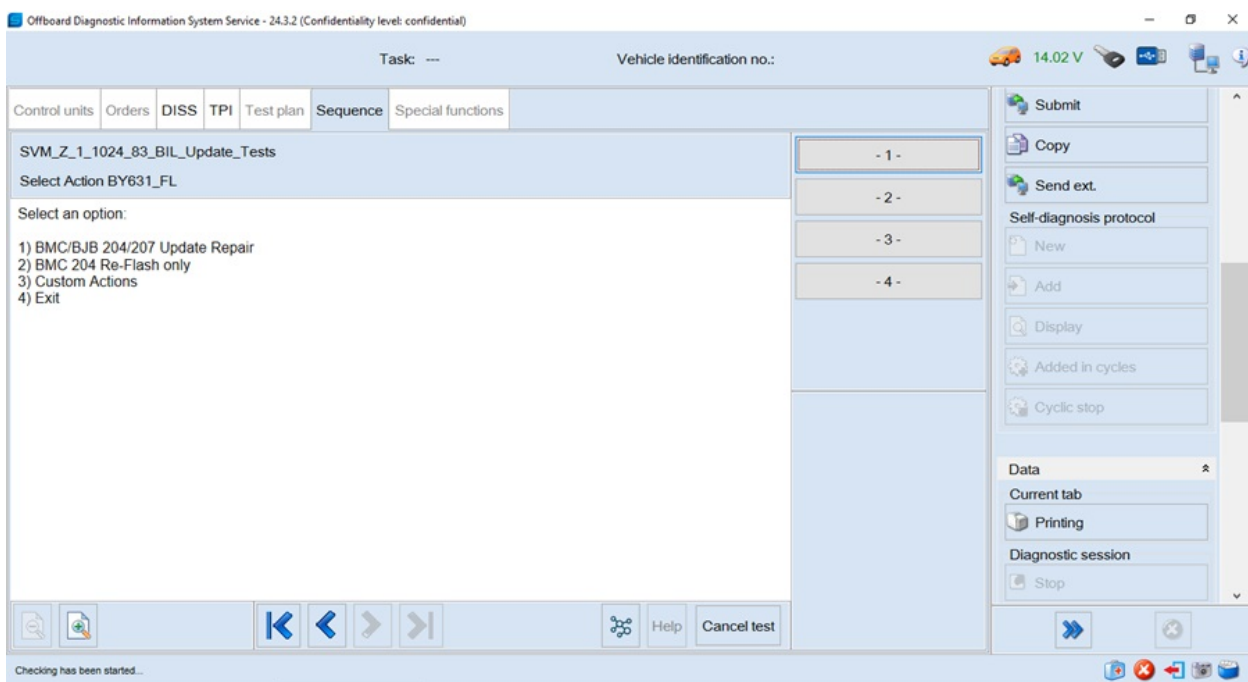
2. Navigate to 'Special functions' and select 'SVM – Pre 372BIL5201 Hotfix Routines', then 'Perform test'.
3. Switch to 'DoIP' when prompted.
4. Select '1) BMC/BJB 204/207 Update Repair' and follow the on-screen instructions.
 - When the tester attempts to flash '008C - Battery regulation control module' you may receive a message informing you that the pre-conditions have not been met. Select 'done/continue'.
 - On the following screen (shown below) select option 2 to attempt to flash the ECU – this should allow the '008C - Battery regulation control module' to flash successfully.

- If the flash fails, perform the below actions.

1. Exit the test.
2. Allow the car to sleep for 5 minutes.
 - a. Turn off the ignition.
 - b. Remove all equipment from the car (Diagnostic tester/dongle, battery charger, keys).
 - c. Close all doors, windows, bonnet and boot lid.
 - d. Lock the vehicle to perform a CAN-BUS sleep (wait 5 minutes).

3. Clear DTCs from '008C - Battery regulation control module'.
 - 3a. To do this, right click on control unit 008C, click Guided Functions and then click 'Clear Fault Memory'.
4. Return to 'Special functions' and run the test plan 'SVM – Pre 372BIL5201 Hotfix Routines'.
5. Within this test plan, select option 2 and run until completion.
6. Once the test has been completed, right click on control unit 008C and select guided functions. Then, read ECU Identification and ensure that the 06D0 (Battery Junction Box) appears as a subsystem within the read identification test plan.
7. Continue to the next SVM update.

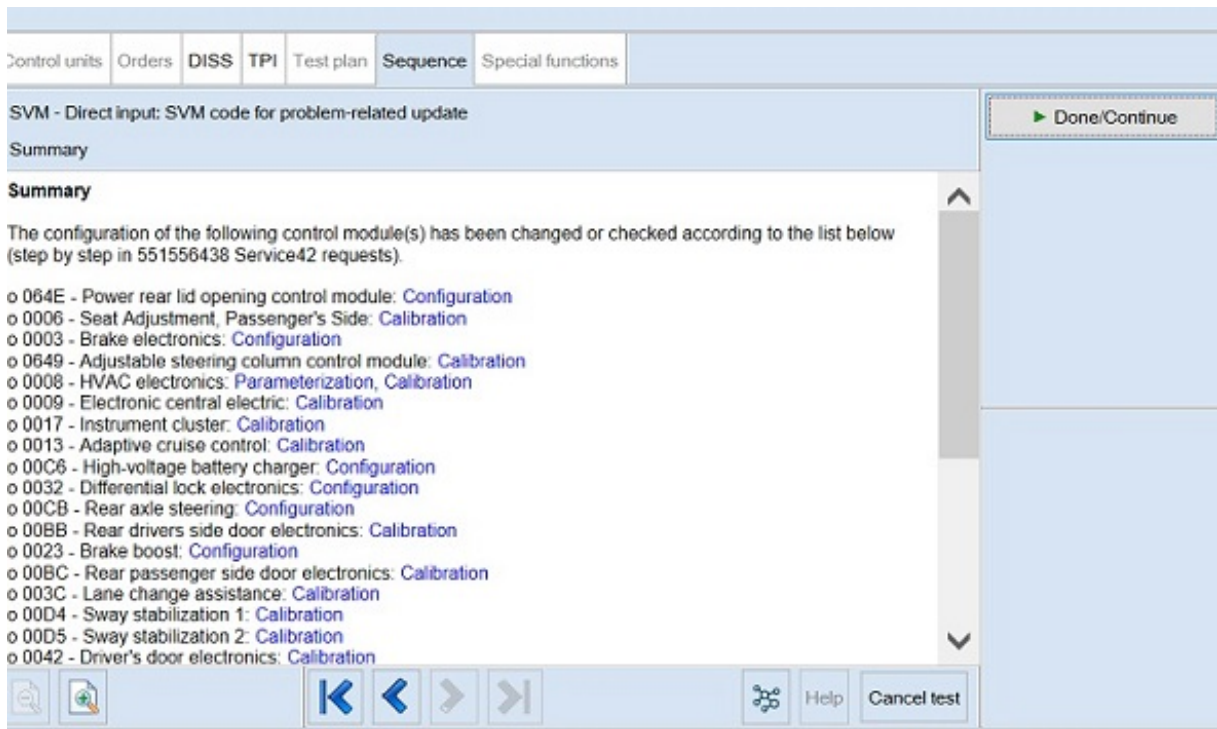
Fig 3

9. If you are presented with this screen (Fig 3) at the end of the update, the update was successful. Please continue to step 11.

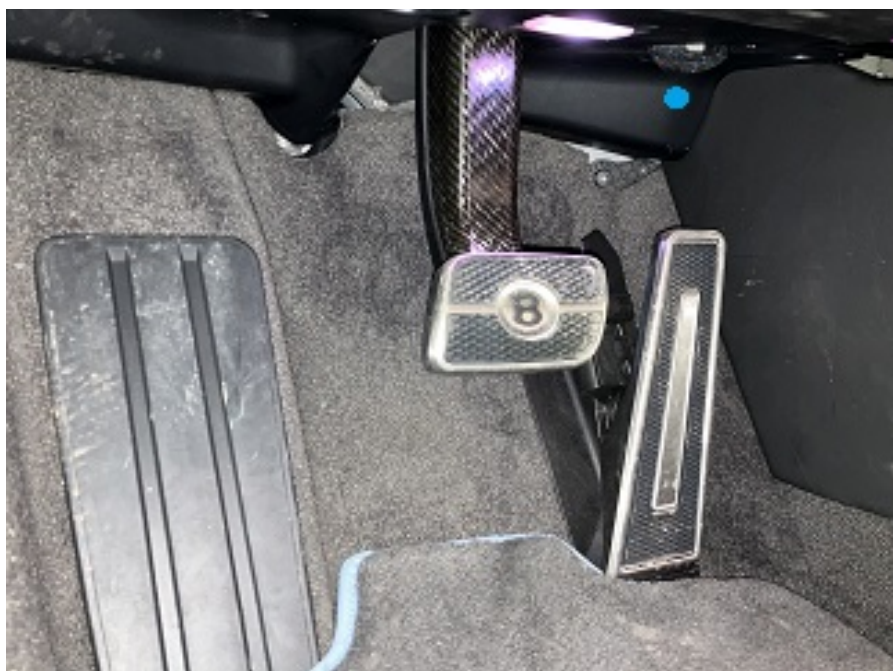
You must also add a blue paint mark as per the picture below.
