Technical Information

75/25 ENU 9102

Various White Messages Regarding Driver Assistance Systems In the Instrument Cluster/Fault Memory Entry "C12D5FA" In the Control Unit for Driver Assistance Systems - ZFAS (75/25)

Model Line: Taycan (Y1A/Y1B/Y1C)

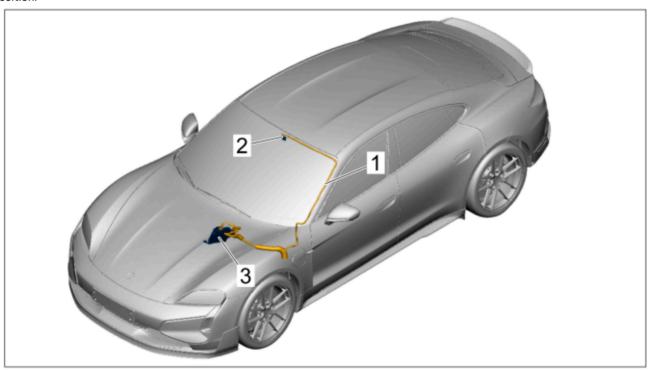
Installation position for the video line - left-hand drive

- 1 Video line
- 2 Front camera for driver assistance systems
- Control unit for driver assistance systems (ZFAS)

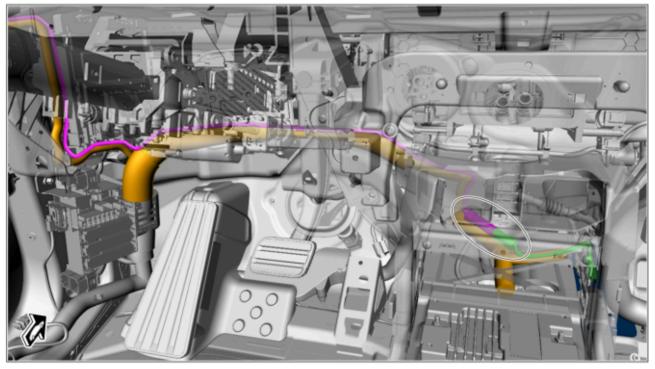
Circle - Video line connection point area

4 Lay the video line in the dashboard area. \Rightarrow Routing in the dashboard area
