# 24KWE: Kongsberg Automotive Right-Hand Shift Stalk

24KWE NHTSA: 24V190 / Transport Canada: 2024-161

11/26/2025

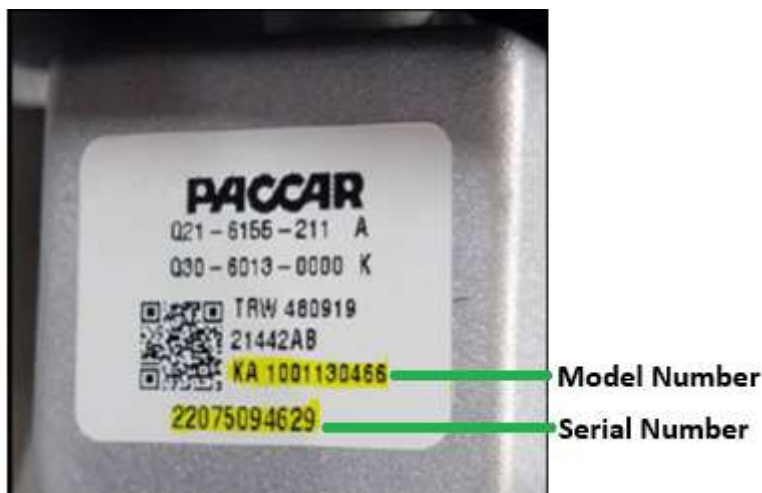
*Right-hand shift stalk part/serial number label*
