# FS015: PACCAR TX-12 MTM Loose Rail Cap Screws

11/10/2025

Transmission - 26

Certain chassis equipped with a PACCAR TX-12 transmission have Mechatronic Transmission Module (MTM) rail cylinder cap screws that could become loose. This may cause the transmission not to shift and the transmission service lamp to illuminate.

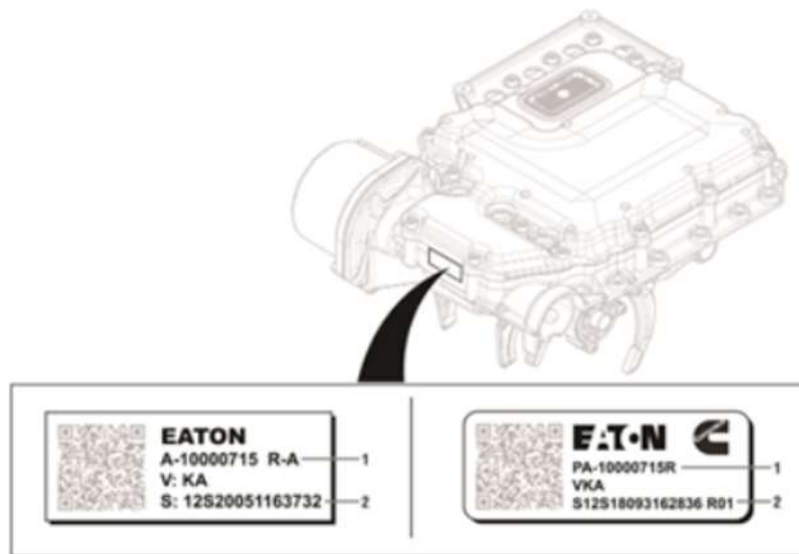
*MTM Label Location*

1. Inspect the Mechatronic Transmission Module (MTM) label for type and serial number:

- If it is an Eaton/Cummins Joint Venture label (pictured below) or the five bolded digits of the MTM serial number are 22342 or sequentially higher (12S**22342**145012), then no repairs are required. File a claim for inspecting the MTM label.

- If it is an Eaton label (pictured below) and the five bolded digits of the MTM serial number are sequentially lower than 22342 (12S**22342**145012), then proceed to step 2.

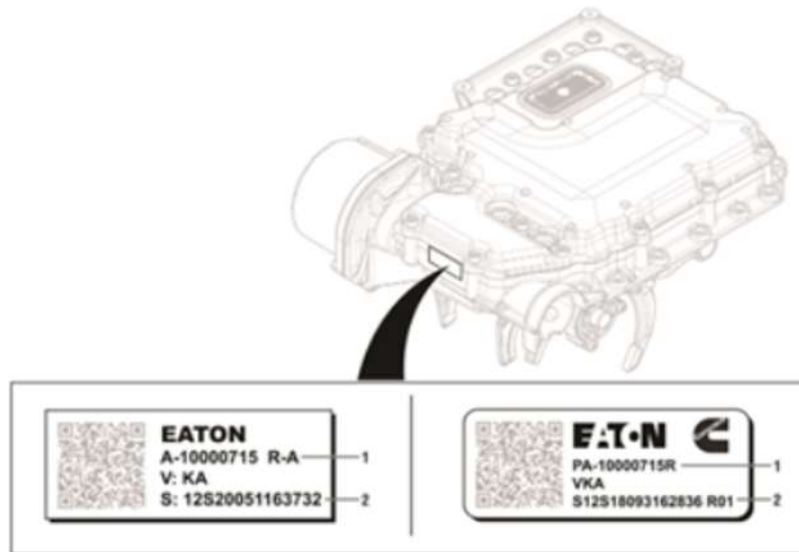
*MTM Label Location*

1. Inspect the Mechatronic Transmission Module (MTM) label for type and serial number:

- If it is an Eaton/Cummins Joint Venture label (pictured below) or the five bolded digits of the MTM serial number are 22342 or sequentially higher (12S**22342**145012), then no repairs are required. File a claim for inspecting the MTM label.

- If it is an Eaton label (pictured below) and the five bolded digits of the MTM serial number are sequentially lower than 22342 (12S**22342**145012), then proceed to step 2.
