Topic	Titanium sports exhaust system - Clamp Installation Bentayga 26MY (SC25/44)
Market area	Germany E02 Bentley rest Europe (6E02),United States E05 Bentley USA and rest America (6E05)
Brand	Bentley
Transaction No.	2079821/2
Campaign number	ED72
Note	
Type	
US code

Titanium sports exhaust system - Clamp Installation | Bentayga | 26MY (SC25
/44)

Release date: Nov 14, 2025

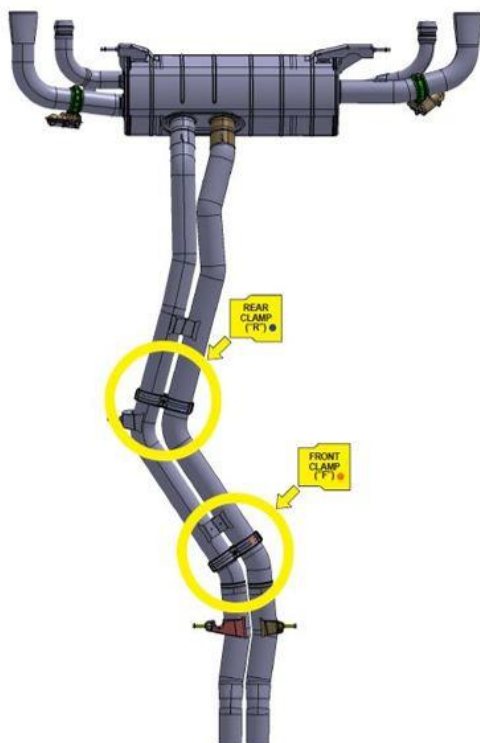
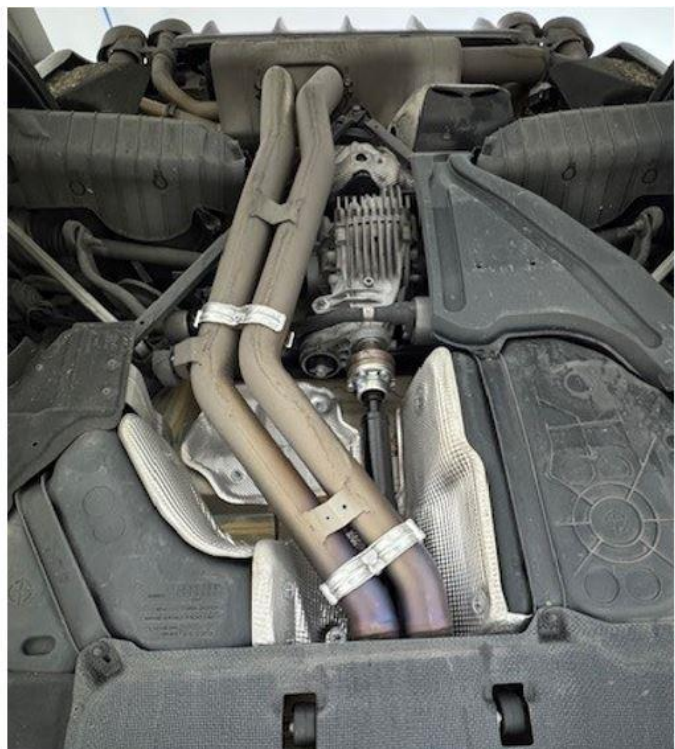
Figure 1. Bottom View of the exhaust system with clamps installed

Affected vehicles have been identified for a containment action with regards to the Titanium Sports Exhaust. Through vehicle testing phases, a potential concern has been identified where a customer may experience a rattle in their exhaust system when the vehicle reaches 30,000–40,000 kms. Clamp brackets are required to be installed to mitigate this potential concern.

2. Identify the front and rear clamp positions as per figure 1 diagram.
