# Technical Service Bulletin

<b>Topic</b>	Engine coolant - Overheat condition - Warning evident within the DIP - DTC's P2B6500 and P2B8600 are evident
<b>Market area</b>	Bentley: worldwide (2WBE),China 723 Volkswagen (Anhui) Automotive CO (6723),China 796 VW Import Comp. Ltd (Vico), Beijing (6796)
<b>Brand</b>	Bentley
<b>Transaction No.</b>	2066669/4
<b>Level</b>	EH
<b>Status</b>	Released for publishing
<b>Release date</b>	Nov 14, 2025

Engine coolant - Overheat condition - Warning evident within the DIP - DTC's P2B6500 and P2B8600 are evident

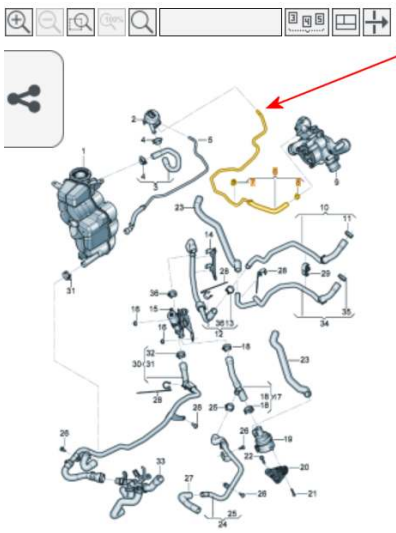
2) Referring to Figure 2 - Locate the vent hose shown (975 122 447H)

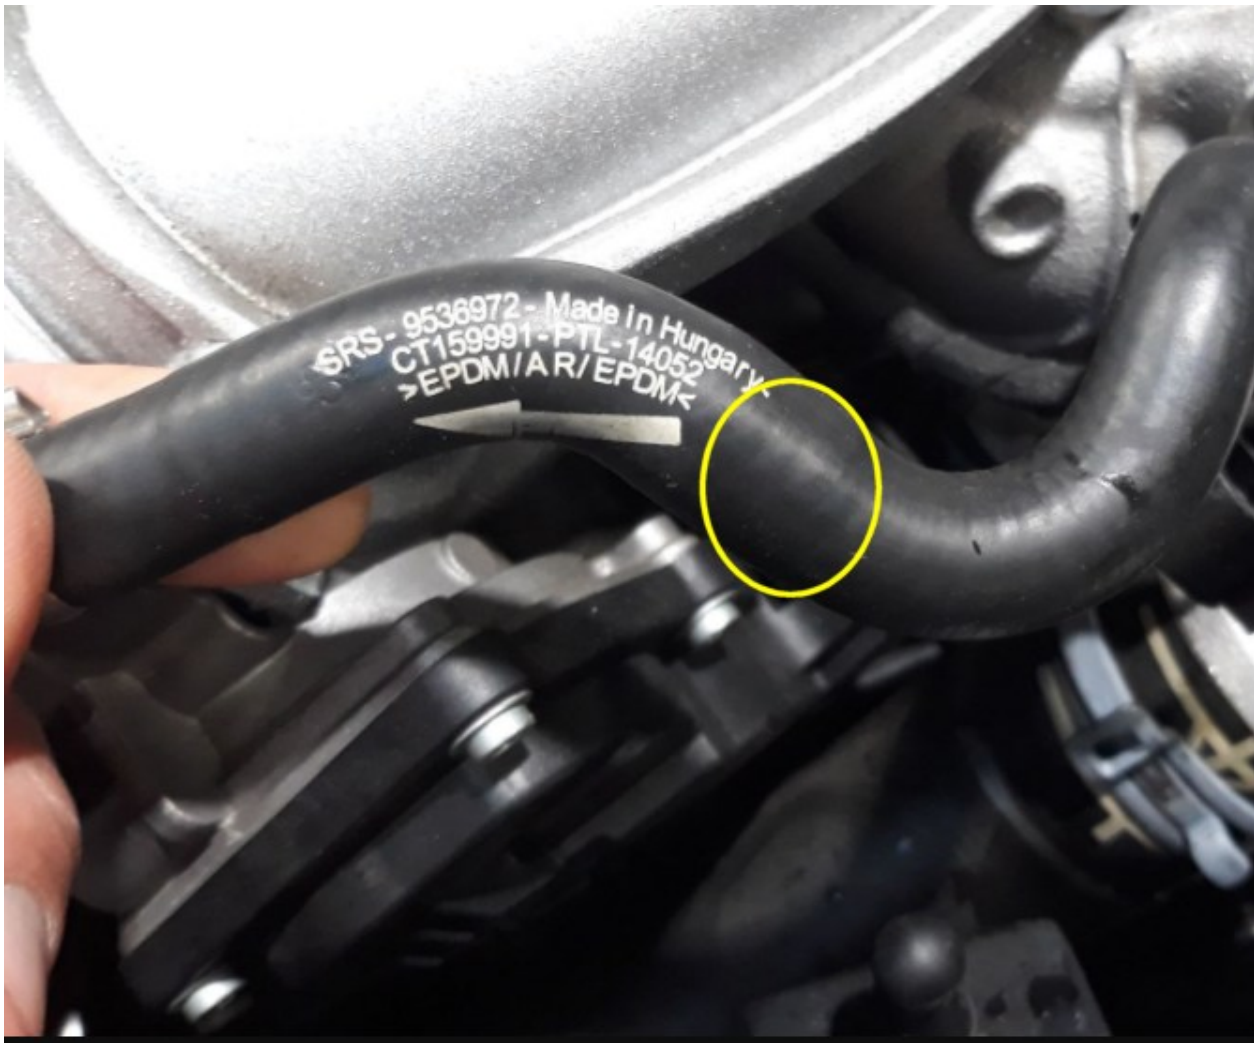
- The vent hose has an internal check valve, the valve is positioned within the vent hose at the location shown in Figure 3 (Circled)

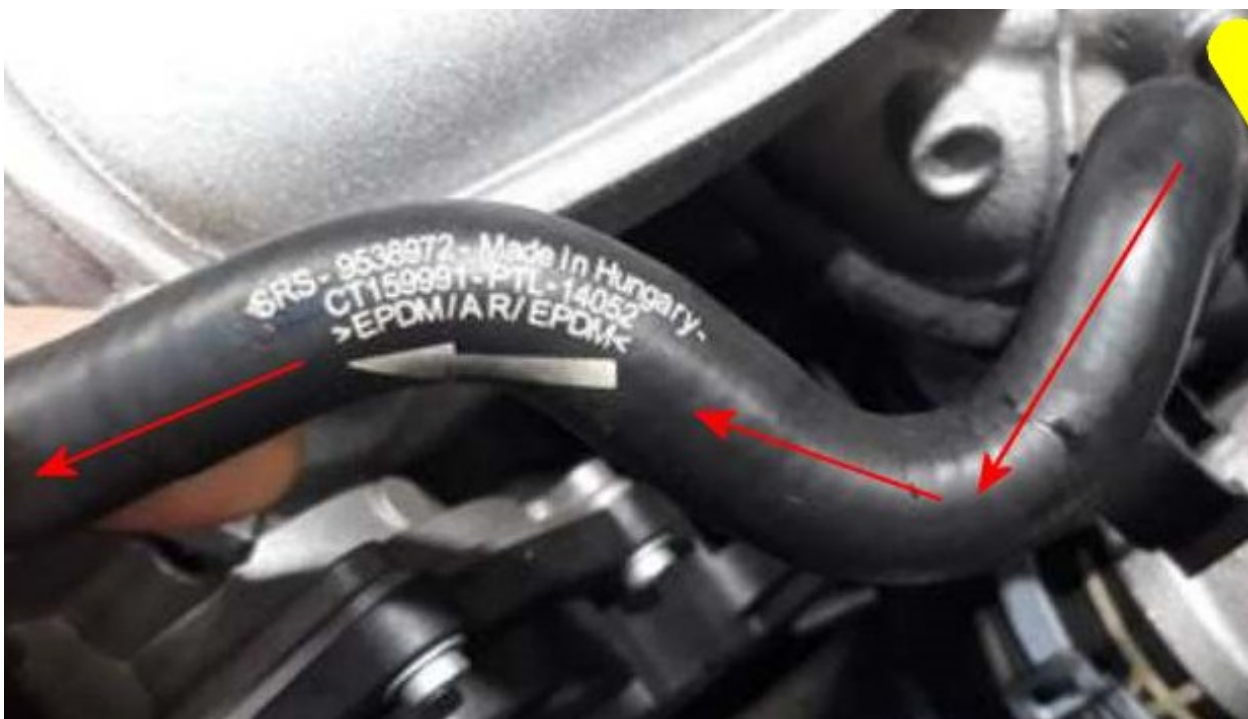
- Referring to Figure 4 - The coolant flows in the direction shown (Arrows) in the event the internal check valve is faulty the flow of the coolant will be restricted (***Causing the symptoms described within the customer findings/workshop findings section***)

4) Replace the vent line

- Once the vent line has been replaced - Referring to Rep.Gr 19 - Bleed the coolant system
- Erase all applicable DTC's
- Conduct a road test - On return check to confirm that no coolant related DTC's are evident

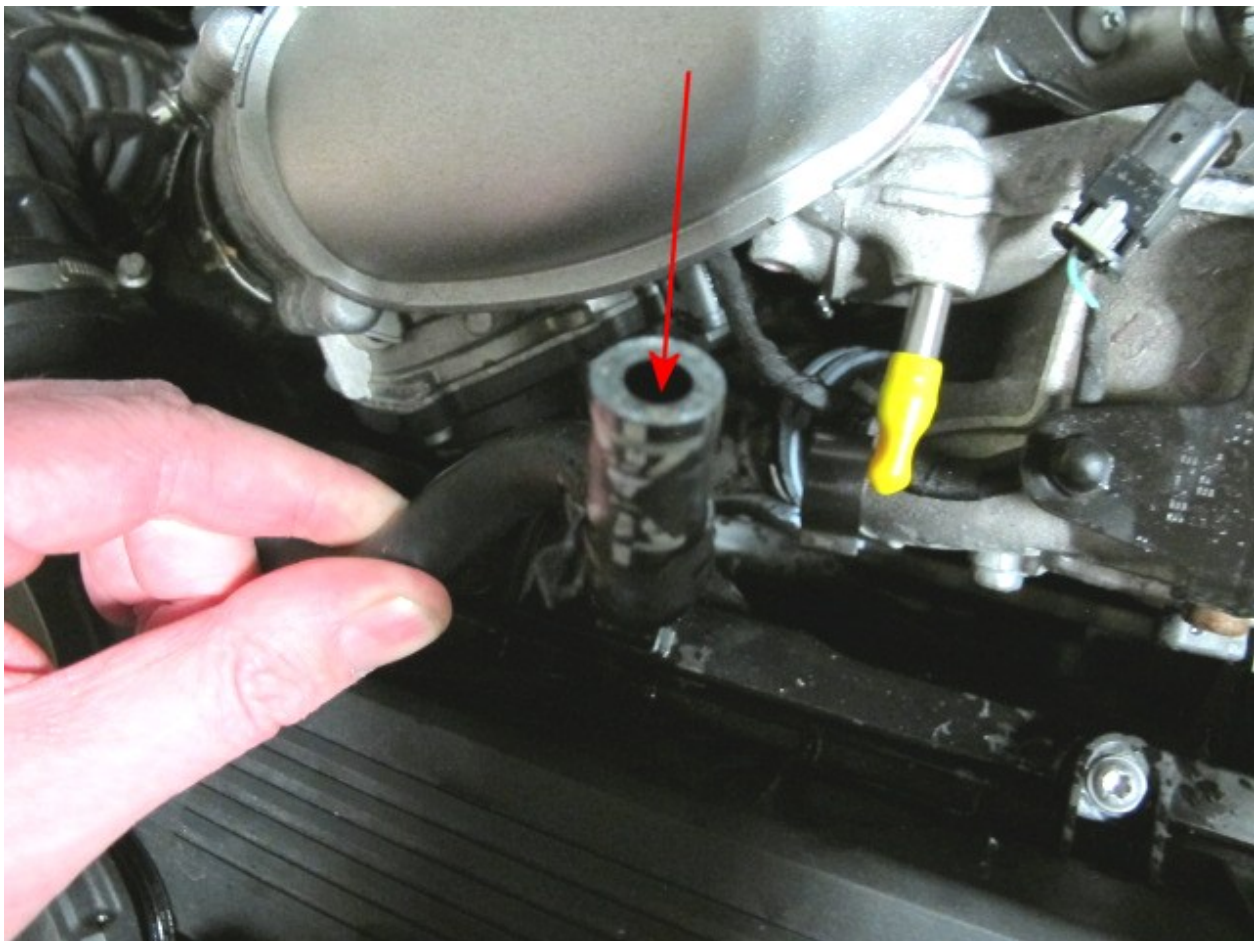
**Does the air flow through the vent line without any restrictions?**

5) Referring to Figure 8 - Apply light air pressure into hose (Arrow)
