Technical Service Bulletin

| Topic | Engine Overheating - Coolant Pump Leaking and Low Coolant Warning W12 |
| Transaction No. | 2071239/4 |

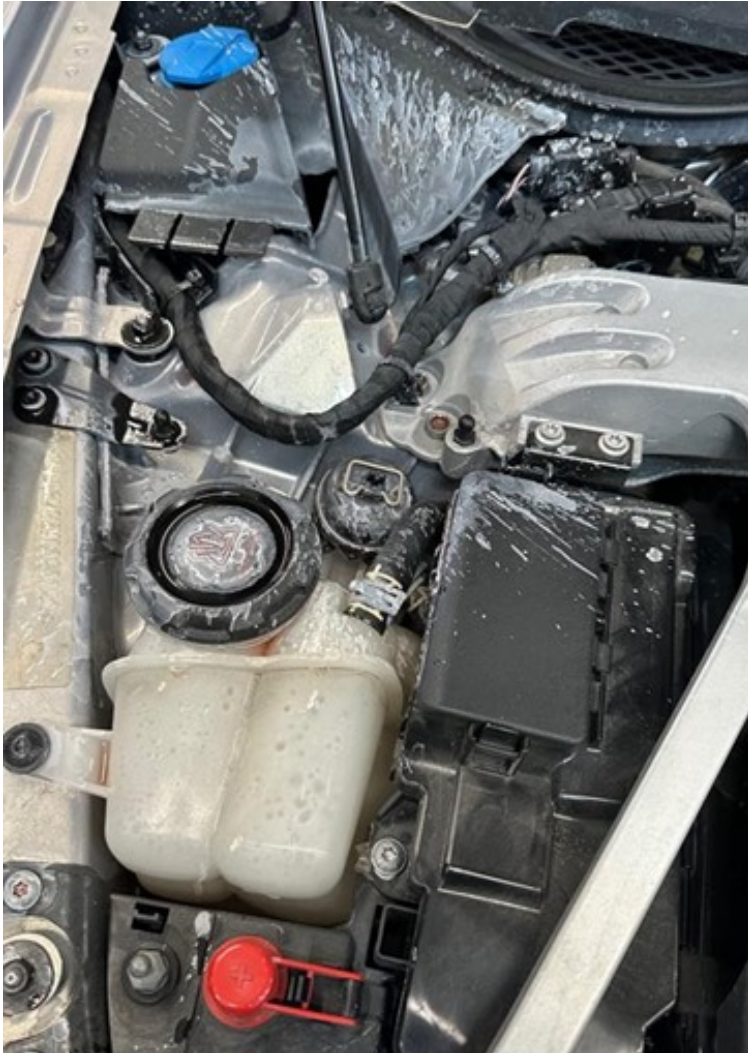
Figure 1

1) On receipt of the vehicle - Take a photograph of the coolant level within the coolant reservoir and inspect the engine bay for any coolant residue (figure 1).

If coolant residue is found in the engine bay, please raise a full technical DISS query and attach a photograph of the coolant residue and a photograph of the coolant level.

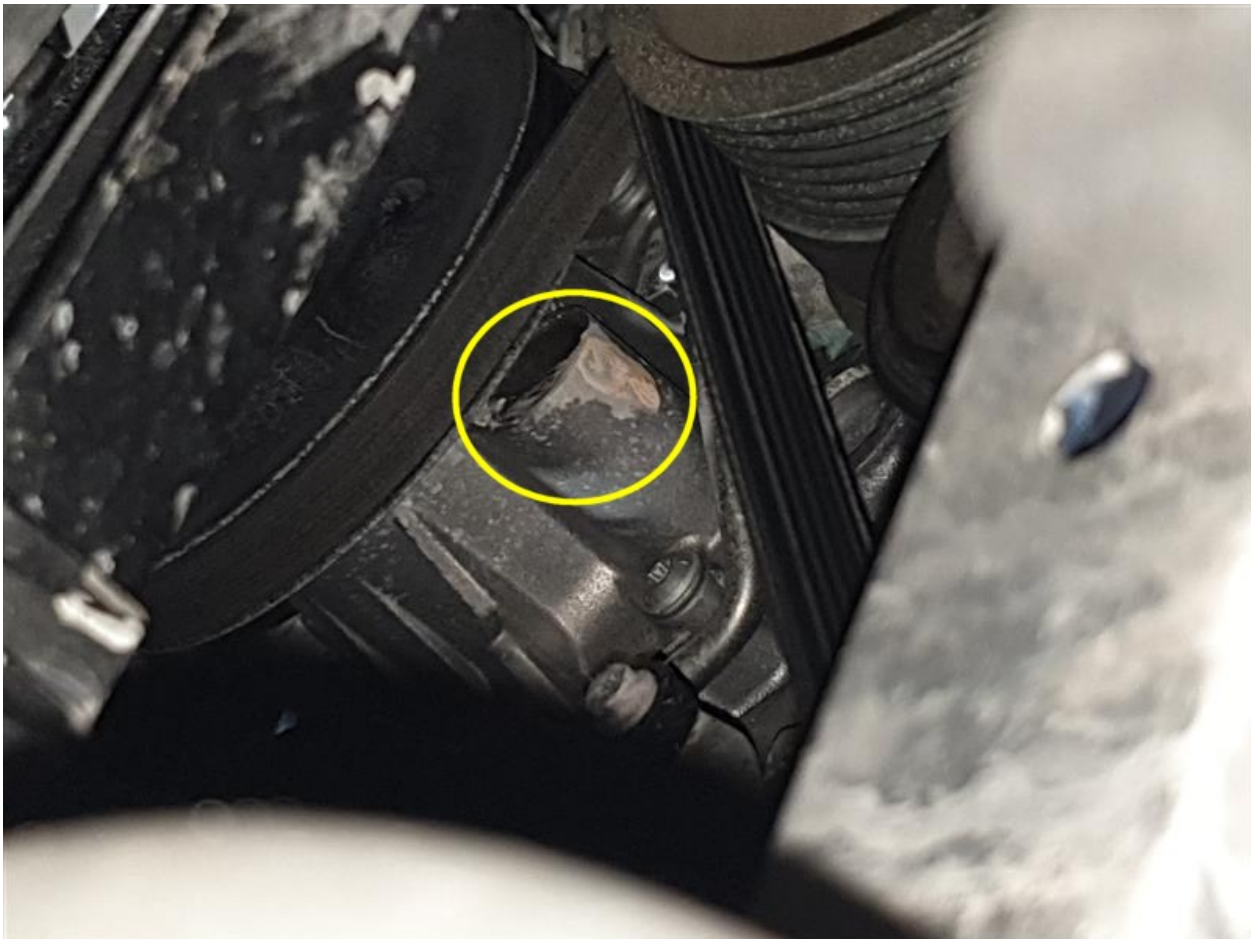
Figure 2

The video shows an example of a coolant pump with no leak, although a small coolant witness mark is evident (Figure 2). In this scenario the coolant witness mark should be cleaned off (using a suitable cleaning agent) to the condition shown in Figure 3

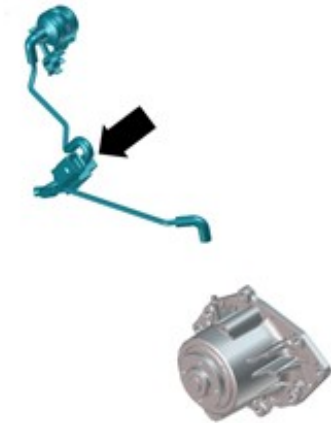
5) Referring to Figure 4 - Disconnect each vacuum hose with care from the Solenoid for coolant circuit N492 - visually monitor for any traces of coolant

VERY IMPORTANT: If traces of coolant are evident during disconnection, take clear photos or record a clear video of any coolant within the vacuum hoses or N492 and attach to a new or existing technical DISS query

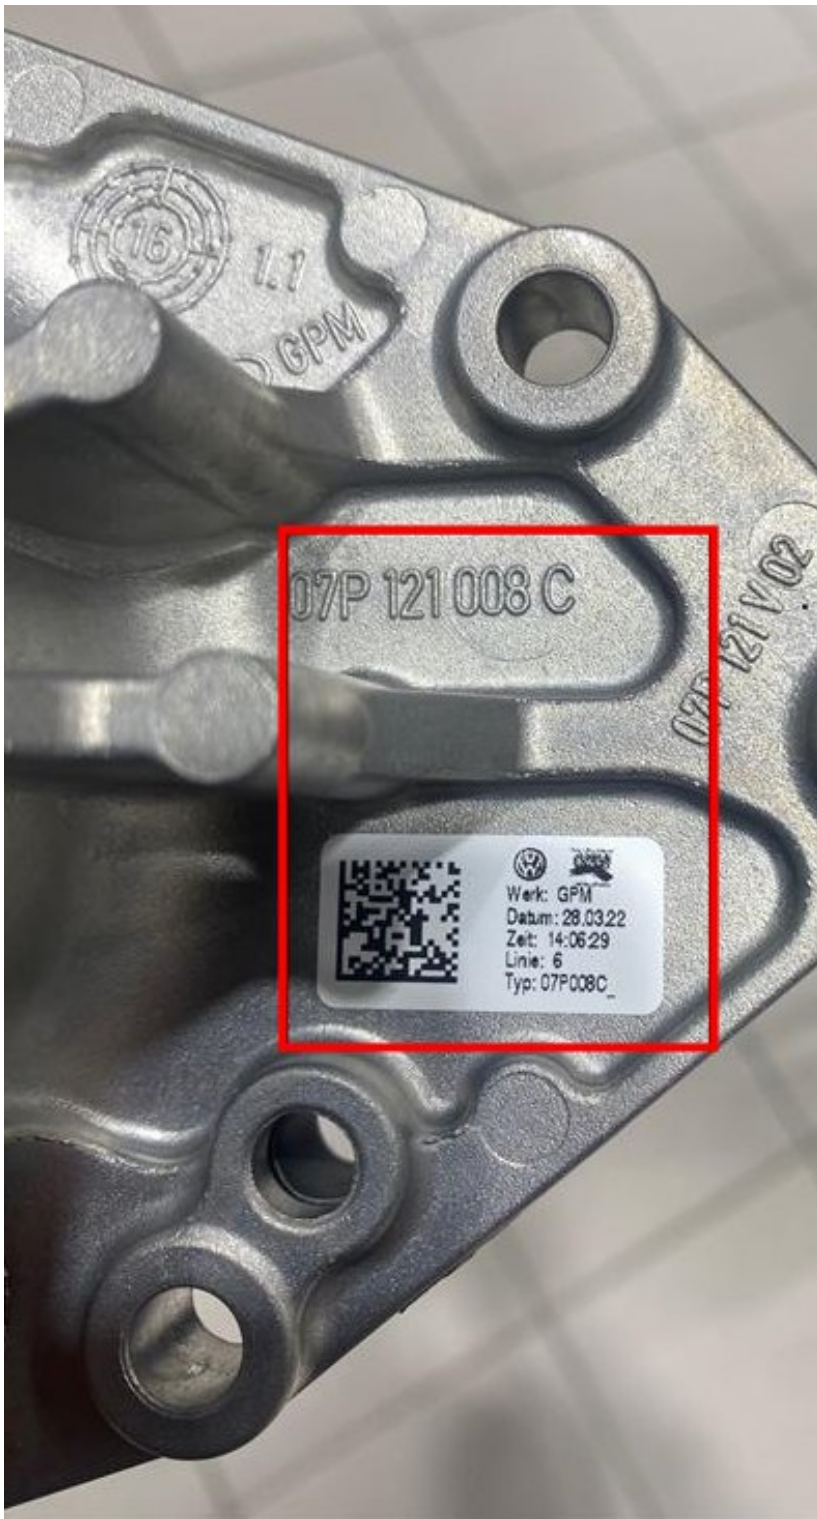
- Clear photo of the coolant level
- Clear photo of the original mechanical coolant pump part number **07P 121 008C** (Figure 5)
- Video of the coolant leak whilst carrying out the pressure test
- Current ODIS log
- Await feedback via DISS before replacing any parts

NOTE: The photo shown in Figure 5 is a C level coolant pump (shown removed from the vehicle for photographic purposes) a borescope may have to be used for photographs of the coolant pump when fitted
