# Technical Service Bulletin

| Topic | Mono Camera Requires Replacement Bentayga 17-19MY |
| Transaction No. | 2078364/1 |
| Release date | Nov 14, 2025 |

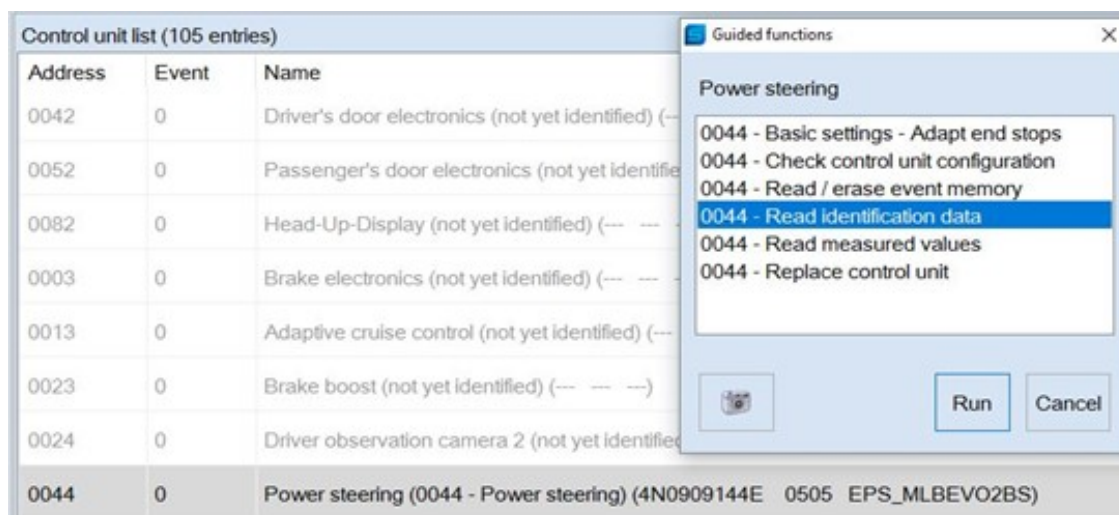
1. Identify the part number of the current part fitted to the vehicle.
  - a. If the current part is 36A 907 217 then proceed to step 2.
  - b. If the current part is 36A 907 217 D then continue to order the D level part as per the ETKA parts catalogue and proceed to step 12.
2. Read Software Information.
  - a. Connect to the vehicle diagnostic system.
  - b. Access the Power Steering Control Module at address 0044.
  - c. Read Identification data.

- c. Identify and note the Software Part Number.
