Technical Service Bulletin

Topic	Right & Left rear turn signal bulb open circuit DTCs Bentayga Series
Market area	Bentley: worldwide (2WBE),China 796 VW Import Comp. Ltd (Vico), Beijing (6796)
Brand	Bentley
Transaction No.	2079586/1
Level	EH
Status	Released for publishing
Release date	Nov 14, 2025

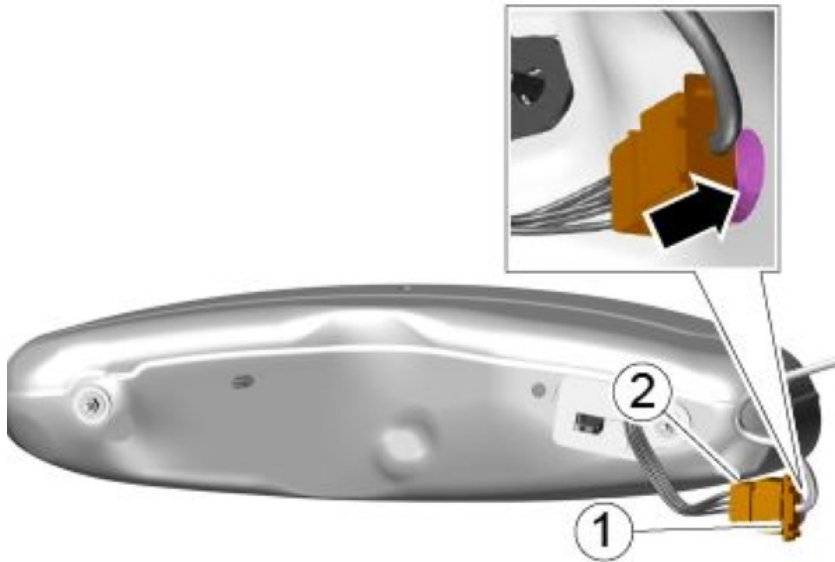
Figure 1

Rear lamp faults may be caused by temporary electrical issues such as poor connector contact or residual DTCs. Disconnecting the lamp and clearing DTCs can reset the system and restore normal function. This process helps confirm whether the fault is transient or requires further technical investigation

4. Disconnect the plug from the suspected faulty rear lamp (ensure the ignition is switched off).

Referring to figure 1 Disconnect the lamp connector -1- from the harness -2-
