Technical Service Bulletin

Topic	Sporadic All-Wheel Drive Warning Continental GT/GTC/Flying Spur 25-26MY
Market area	Bentley: worldwide (2WBE),China 796 VW Import Comp. Ltd (Vico), Beijing (6796)
Brand	Bentley
Transaction No.	2077545/5
Level	EH
Status	Released for publishing
Release date	Nov 14, 2025

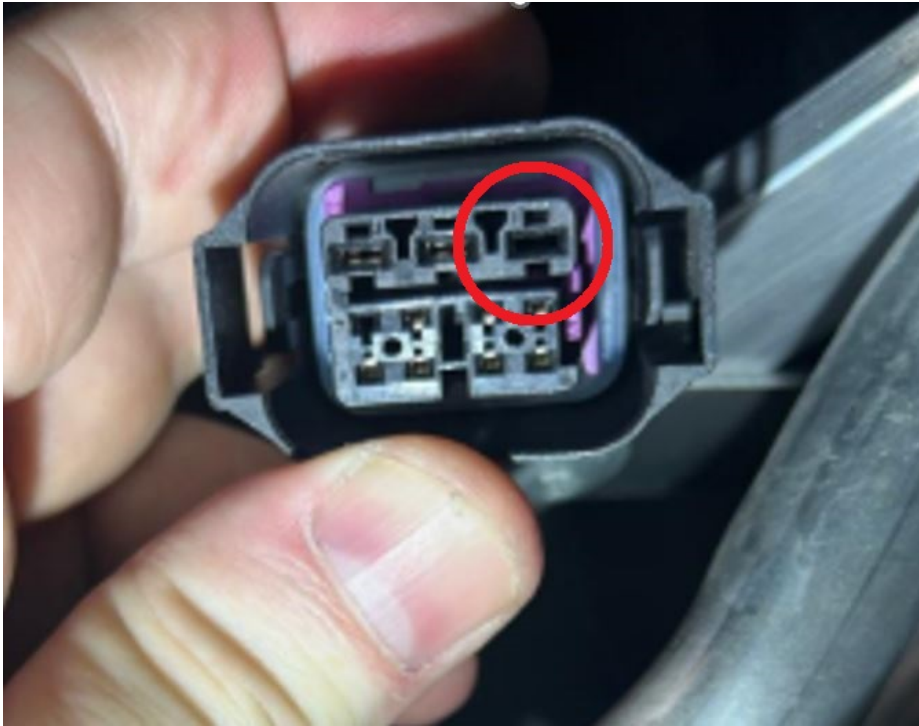
Figure 1

Potential issue with the T16-way connector at J647, causing intermittent faults in the differential lock system due to:

- Poor electrical contact
- Corroded or loose terminals
- Defective terminals.

3. If any terminals are found to be defective as per the example in figure 1.

- Replace all all the defective individual terminals (part number P00427711).

- If required replace the entire 16-way connector at the J647 unit (part number P00293586).
