# Technical Service Bulletin

<b>Topic</b>	Right & Left rear turn signal bulb open circuit DTCs   Bentayga Series
<b>Market area</b>	Bentley: worldwide (2WBE),China 796 VW Import Comp. Ltd (Vico), Beijing (6796)
<b>Brand</b>	Bentley
<b>Transaction No.</b>	2079586/2
<b>Level</b>	EH
<b>Status</b>	Released for publishing
<b>Release date</b>	Nov 26, 2025

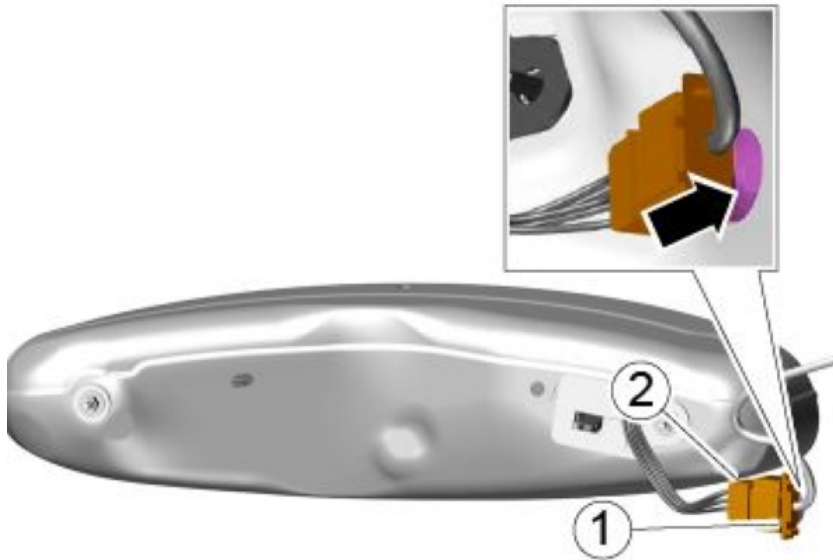
Figure 1

- B11E913: Left rear turn signal bulb Open circuit
- B11EB13: Right rear turn signal bulb Open circuit

Rear lamp faults may be caused by temporary electrical issues such as poor connector contact or residual DTCs. Disconnecting the lamp and clearing DTCs can reset the system and restore normal function. This process helps confirm whether the fault is transient or requires further technical investigation

4. Disconnect the plug from the suspected faulty rear lamp (ensure the ignition is switched off).

*Referring to figure 1 Disconnect the lamp connector -1- from the harness -2-*

5. Wait for 20 minutes before proceeding.

6. Reconnect the plug to the rear lamp.
