# SS 3163 FTL Power Steering Reservoir Fill Cap Venting

Freightliner vehicles equipped with 2 & 4 quart capacity polymer power steering reservoirs

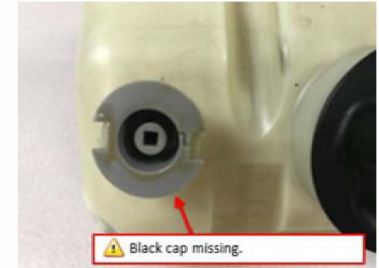
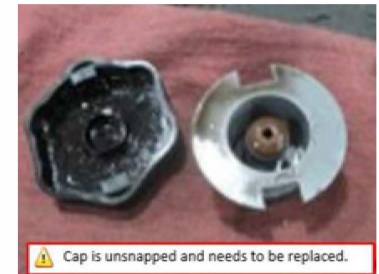
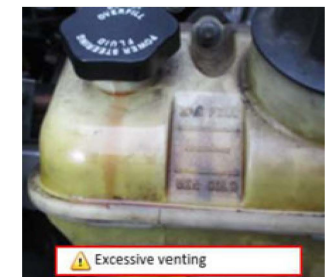
## Examples of Damaged Fill Caps

If a fill cap is damaged and not venting correctly, this can lead to a drop in power steering fluid level. Depending on operating conditions, there can also be an excessive amount of debris build up on the reservoir body.

Thoroughly wash and wipe clean the reservoir body >> Ensure power steering fluid level is within limits >> Replace the fill cap with a new part.
