Service Solution 3174 – FTL ICC5 B-Panel Gauges Intermittently Not Being Displayed

Affected Models: 4th Gen Cascadia w/ ICC5

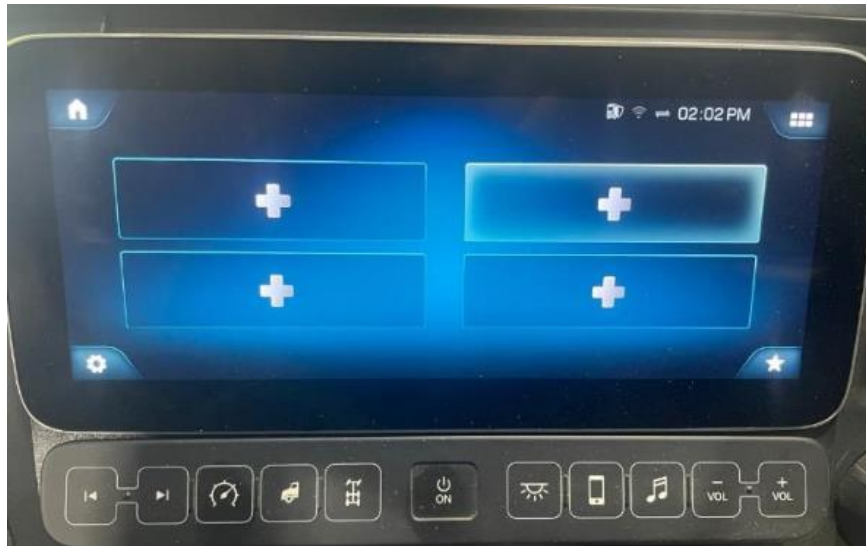
Intermittently during first start the custom gauges in the B-panel are not being displayed. Subsequently trying to add them in again will not work. The B-panel could also become unresponsive to different inputs. This can also cause your SiriusXM to stop outputting audio.

The symptoms resemble an issue with the way the memory is being loaded. Currently it is under investigation.

The solution is to key cycle the truck and if that does not work then pull the F16 fuse to the Connect5 ECU wait 10-15 seconds before reinserting. This will typically reboot the ICC5 module restoring normal functionality to the B-panel.
