Mitsubishi Motors North America, Inc. TECHNICAL INFORMATION NOTICE

Front Bumper Cover Installation – Preventing Detachment

No: TIN-25-51-001

2022-2025 Outlander

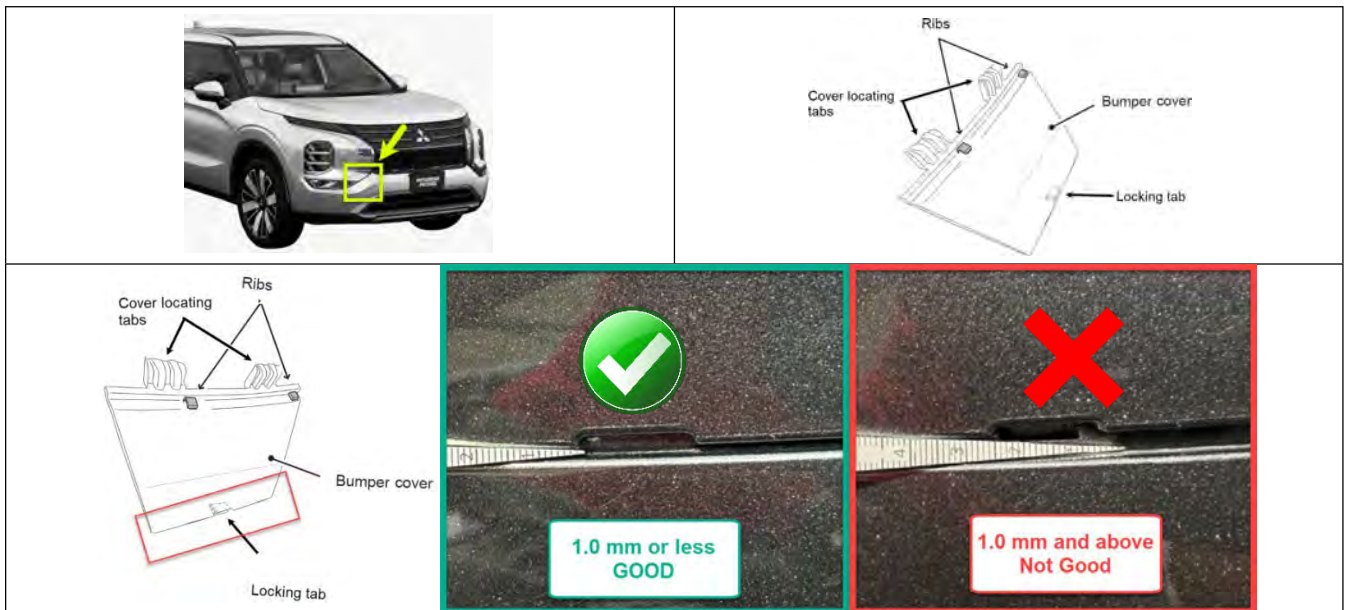
When the bumper cover is installed inward beyond specification during installation, the cover's external ribs can bind against the bumper. This prevents the locking tab at the lower section from fully engaging, leaving a large visible gap at the lower edge, and compromising clip proper securement.

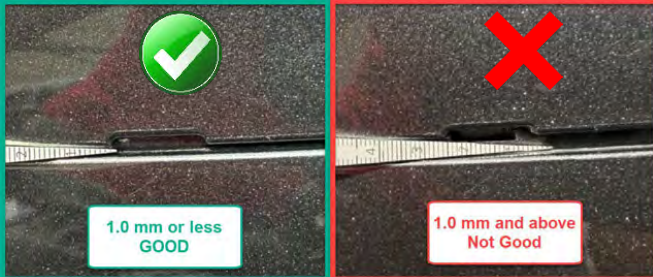
3	Check for visible excessive gap at the lower edge that can compromise clip engagement.
