# TECHNICAL SERVICE BULLETIN

## Steering Column Shrouds Misaligned Or Pushed Out

**25-2580**

<b>Ford</b> 2025 Explorer	BlueCruise Built on or before 15-May-2025
------------------------------	----------------------------------------------

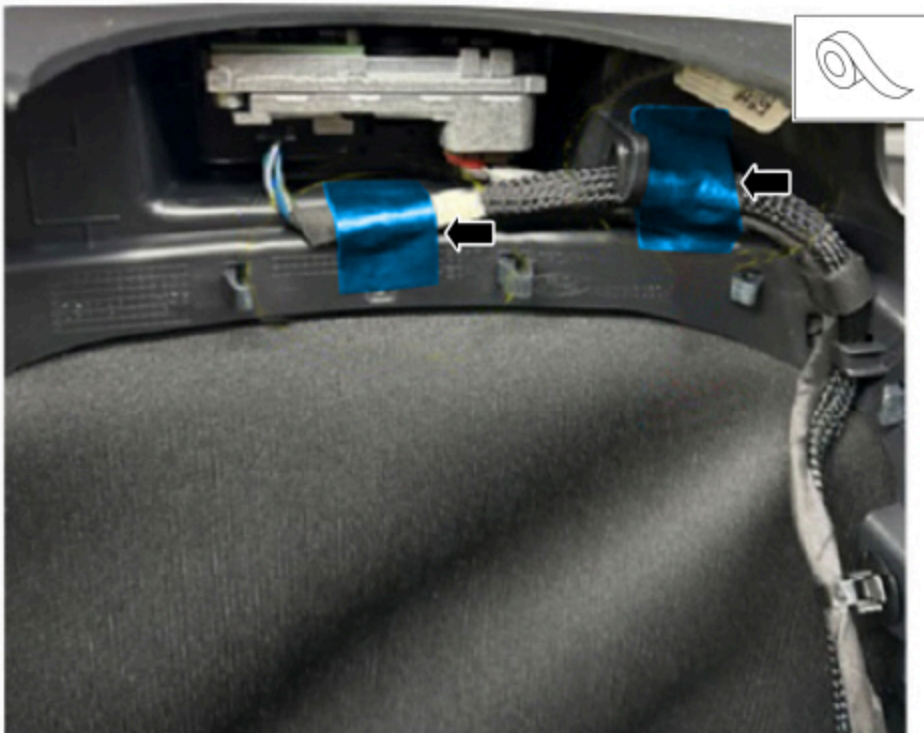
Figure 1

**Issue:** Some of the vehicles listed in the Model statement above may exhibit steering column shrouds that are misaligned or pushed out. This may be due to the wiring harness causing interference with the upper and lower shroud connection.

1. Access the wiring harness at the steering column shrouds connection. Refer to the [WSM](#), Section 501-05 Removal and Installation > Steering Column Shrouds.
2. Using electrical tape or equivalent, secure the steering column shroud wiring harness away from the upper and lower steering column shroud tabs. (Figure 1)
