**Date:** 25.11.2025      **Affected Models:** Emira      **Affected Regions:** All regions      **Affected Volume:** N/A      **Number:** 131-25012

Introduction of the instrument panel upper trim assembly as a service replacement part.

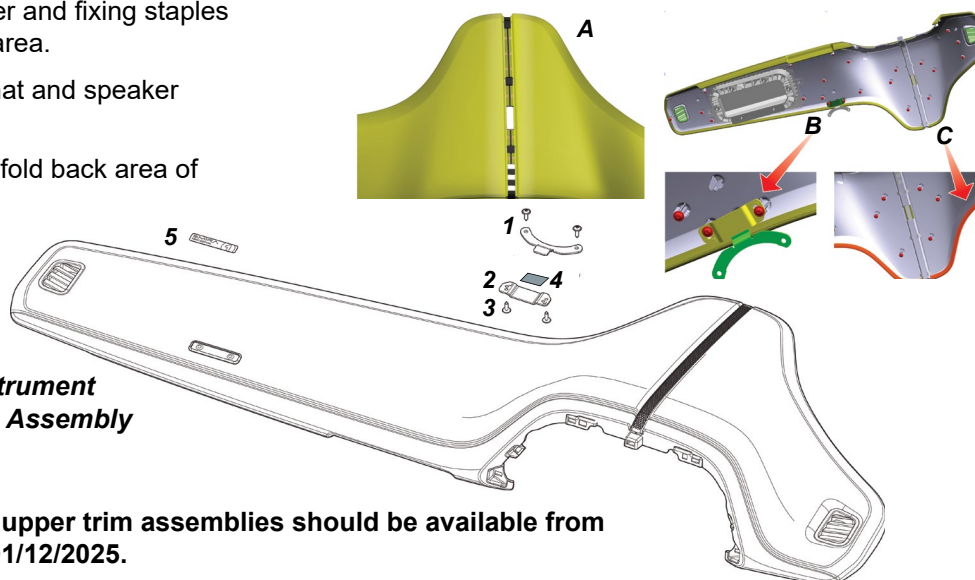
**Service Level Instrument Panel Upper Trim Assembly**

Soon, it will be no longer necessary to order a complete instrument panel assembly if replacement is required because of trim cracking/shrinkage etc to the upper trim assembly.

- A. Additional leather and fixing staples above the DIM area.
- B. Addition of top hat and speaker bracket.
- C. Additional 5mm fold back area of leather trim.

Instrument panel upper trim assemblies should be available from week beginning 01/12/2025.

The service level upper trim assembly is pre-fitted with the Plate-Instrument Panel Mid Uppr Trim, but a replacement emblem (5), as well as an upper trim assembly fixing kit (part number 8902630235) with the items listed below must also be ordered on LCMS.

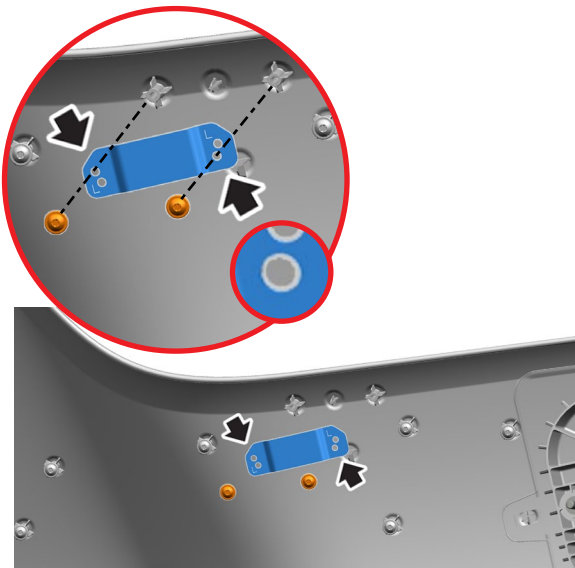
Fitment of the top hat bracket (item 3 of fitting kit) and speaker bracket (item 2 of fitting kit), stops the forward edge of the instrument panel upper trim assembly from lifting away from the instrument panel assembly.

Apply the anti-squeak tape (item 4 of the fitting kit) onto the recessed section of the top hat bracket.

For right-hand drive vehicles, attach the top hat bracket using the screw holes that are not marked.
