GROUP	MODEL
ENG	2021-2023MY Sorento (MQ4a)
NUMBER	DATE
257	December 2025

## TECHNICAL SERVICE BULLETIN

# ITM REPLACEMENT AND ECM & TCM LOGIC IMPROVEMENT (CA2508)

This bulletin provides information to replace the Integrated Thermal Management Module (ITM) and then upgrade the Engine Control Module 'ECM' and (if applicable) the Transmission Control Module 'TCM' system software on certain 2021-2023MY Sorento (MQ4a) vehicles produced from September 09, 2020 through December 19, 2023. The affected vehicles may experience an illuminated Multifunction Indicator Lamp (MIL) 'ON' with DTC(s) P218100, P2181F0, and/or P2181F1 stored. This condition may occur due to degradation of the diaphragm inside the ITM. There are no drivability or other symptoms associated with this condition. Follow the procedure outlined in this publication to replace the ITM and then upgrade the ECM and TCM systems (as applicable). Refer to [SST081](#) for software upgrade instructions using Kia Diagnostic System (KDS) tablet and VCI-II and confirm the Upgrade Event Number/Name, ROM ID Information, and Manual Mode passwords (if applicable) on the applicable vehicle.

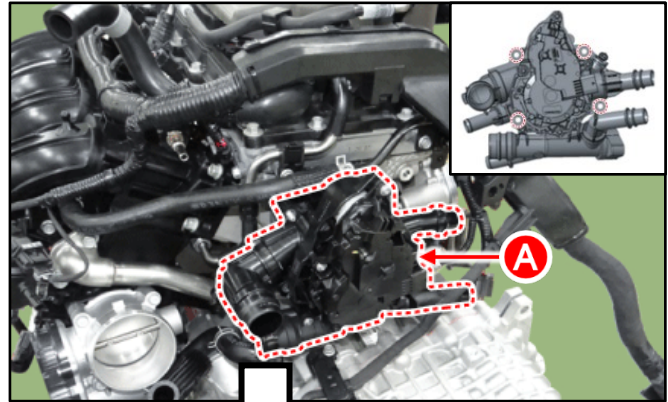
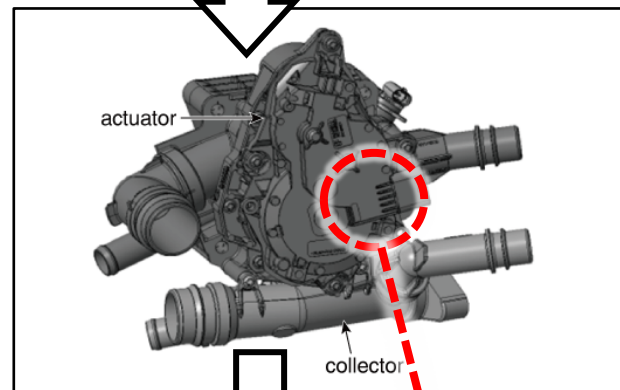
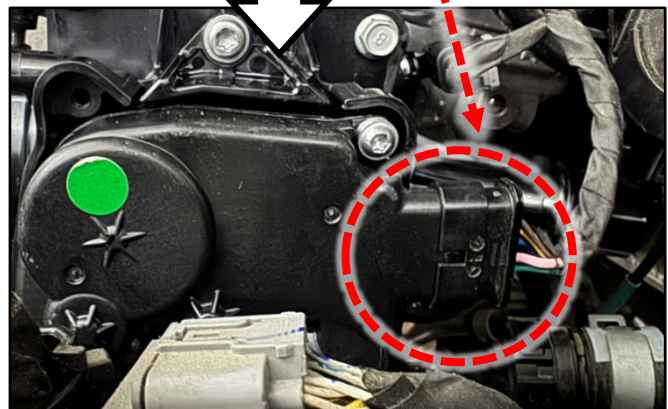
**Note:** The ITM connection orientation changes after replacing the new ITM part. The locking tab will face the engine.

Trying to make the connection on the new ITM in the same orientation as the original ITM may damage the connector pins/terminals.

1. Replace the Integrated Thermal Management Module 'ITM' (A) by referring to "Engine Mechanical System → Cooling System → Integrated Thermal Management Module (ITM) → Repair procedures" in the applicable Shop Manual on KGIS.

Tightening torque for bolts:  
7.2 - 8.7 lb.ft (9.8 - 11.8 N.m)

**Do NOT dismantle the actuator and collector.** The *new* ITM is supplied as and assembly unit.

2. Reinstall all removed parts in reverse order of removal.
