REFERENCE:	TSB: 08-343-25 REV. A GROUP: 08 - Electrical	Date:	December 3, 2025	REVISION:	08-343-25
VEHICLES AFFECTED:	<p>2025 (DJ) RAM 2500 Pickup 2025 (D2) RAM 3500 Pickup 2025 (DP) RAM 4500/5500 Cab Chassis 2025 (DD) RAM 3500 Cab Chassis This bulletin applies to vehicles equipped with the Cluster 7.0" TFT Color Display (Sales Code JAL).</p>	MARKET APPLICABILITY:			
		<input checked="" type="checkbox"/> NA <input checked="" type="checkbox"/> MEA <input checked="" type="checkbox"/> SA <input checked="" type="checkbox"/> IAP <input type="checkbox"/> EE <input type="checkbox"/> CH NOTE: This bulletin applies to the North America, South America, India & Asia Pacific and Middle East & Africa markets.			
CUSTOMER SYMPTOM:	<p>Customers may experience one or more of the following:</p> <ul style="list-style-type: none"> • **The IPC does not display the correct Tire Pressure Monitoring System (TPMS) graphic in the IPC (For dually vehicles only) Fig. 1.** • While driving, resetting the Diesel Particulate Filter (DPF) gauge causes the IPC to freeze on that screen. The left-side steering wheel controls (used for navigating the IPC) becomes unresponsive while the right-side controls for cruise

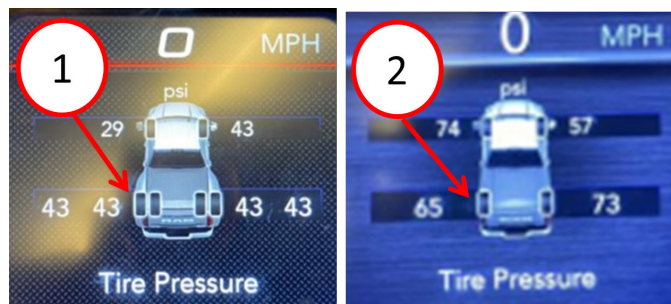
Fig. 1

****Correct And Incorrect Dually Tire Pressure IPC Screens****

1 - CORRECT Dually Tire Pressure IPC Screen
 2 - Incorrect Dually Tire Pressure IPC Screen

This bulletin involves updating the IPC with the latest available software.

1. Reprogram the IPC with the latest software. If issues arise when flashing a module using the wiTECH Diagnostic Application, please submit a ticket to the Helpdesk. The helpdesk can be found within the Help menu.
2. Using wiTECH, perform a "PROXI Alignment Procedure". This routine is available under the 'Vehicle Preparations' tab of wiTECH.
3. Clear all DTCs that may have been set in any module due to reprogramming. The wiTECH application will automatically present all DTCs after the flash and allow them to be cleared.
