<b>REFERENCE:</b>	<b>TSB:</b> 08-389-25 <b>GROUP:</b> 08 - Electrical	<b>Date:</b>	December 2, 2025	<b>REVISION:</b>	—
<b>VEHICLES AFFECTED:</b>	<b>2023 - 2025 (RU) Chrysler Pacifica / Voyager</b> <b>This bulletin applies to vehicles equipped with:</b> <ul style="list-style-type: none"> <li>• Uconnect 5 w/10.1" Display (Sales Codes UBN).</li> <li>• Uconnect 5 w/10.1" Display (Sales Codes UEN).</li> <li>• Uconnect 5 w/10.1" Display (Sales Codes UBG).</li> <li>• Uconnect 5 w/10.1" Display (Sales Codes UEG).</li> </ul>			<b>MARKET APPLICABILITY:</b> <input checked="" type="checkbox"/> NA <input type="checkbox"/> MEA <input type="checkbox"/> SA <input type="checkbox"/> IAP <input type="checkbox"/> EE <input type="checkbox"/> CH <b>NOTE: This bulletin applies to North America markets.</b>	
<b>CUSTOMER SYMPTOM:</b>	<b>Customers may experience one or more of the following:</b> <ul style="list-style-type: none"> <li>• Pressing the left steering wheel control to cycle through the presets, skips through several of the preset channels and calls other SXM stations not on the preset list.</li> <li>• After an overnight sleep cycle, preset bar stays blank in the Media tab and media widget.</li> <

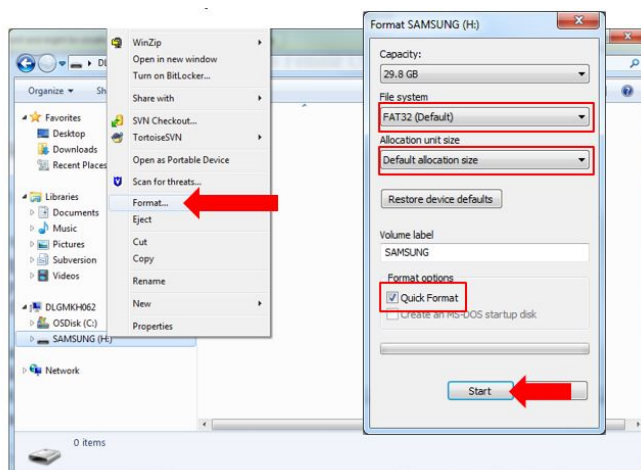
**Fig. 1**

### Formatting The USB Flash Drive

1. Check if the radio software has been updated. Go to “Vehicle Settings” then select "System Information" and look for “Radio Version”.
2. Was the radio software at or above U33.43?
  - YES >>> This bulletin does not apply.
  - NO >>> Proceed to [Step 3](#).
3. Has a **4 GB** USB flash drive been created?
  - YES >>> Proceed to [Step 13](#).
  - NO >>> Proceed to [Step 4](#).
4. Perform the following steps to format the USB flash drive [Fig. 1](#).
  - Select “FAT32” format.
  - Select “Default allocation size” under Allocation Unit Size.
  - Select “Quick Format” under Format Options.
  - Click “Start”.

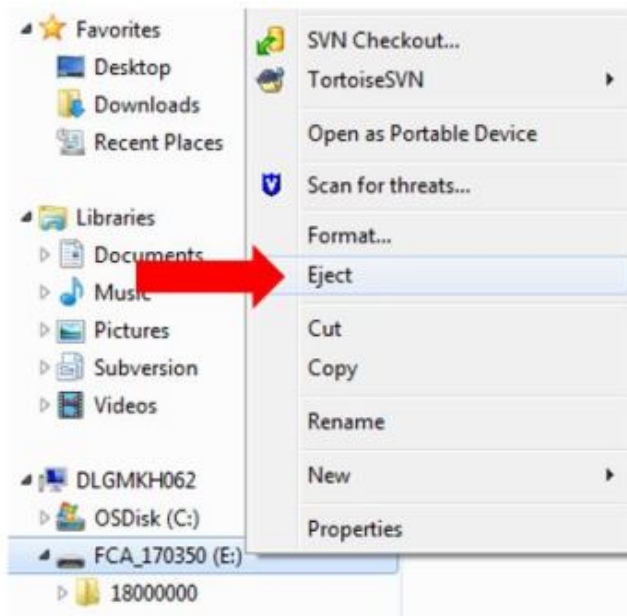
Fig. 3

Ejecting The USB Flash Drive

11. Perform the following steps to properly eject the USB flash drive [Fig. 3](#):
  - a. Right click on the location of the USB flash drive.
  - b. Click "Eject" to avoid data corruption.
  - c. Remove the USB flash drive from the PC.

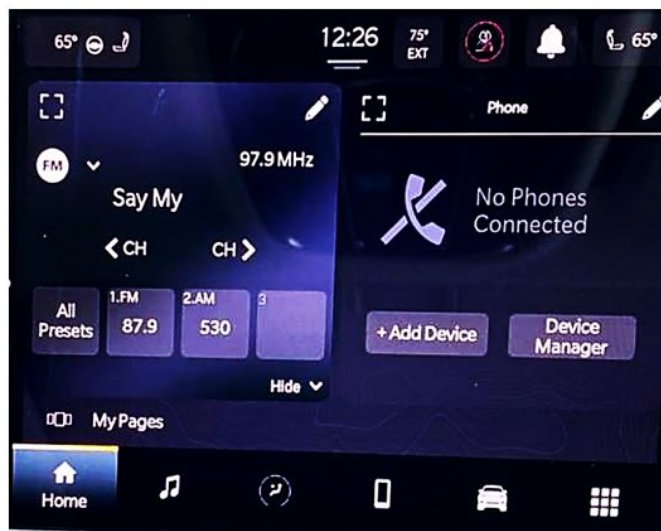
Fig. 4

Home Screen

14. Start the vehicle and insert the USB flash drive into the USB port.
15. Vehicle must be out of "Ship Mode". Starting at the radio 'Home' screen Fig. 4.

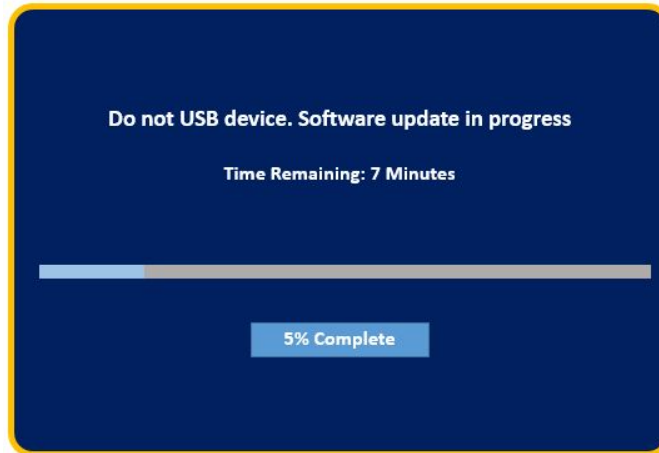
**Fig. 8**

Update In Progress Screen

20. The update will take approximately 15-20 minutes [Fig. 8](#).

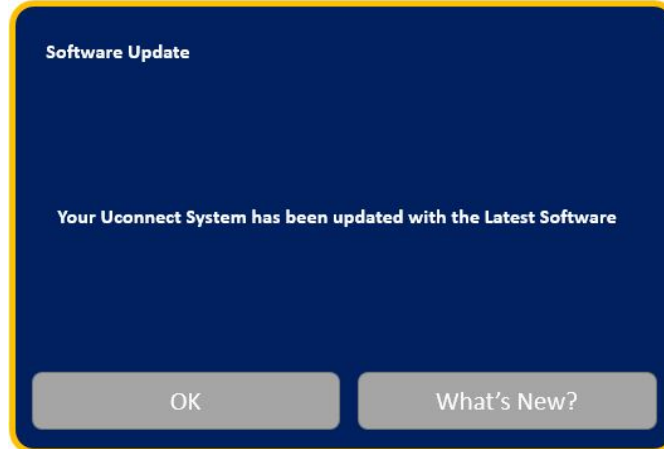
**Fig. 9**

Software Updated Screen

21. The radio will reboot and you will observe the update screen after the splash screen once the update has been successful [Fig. 9](#).

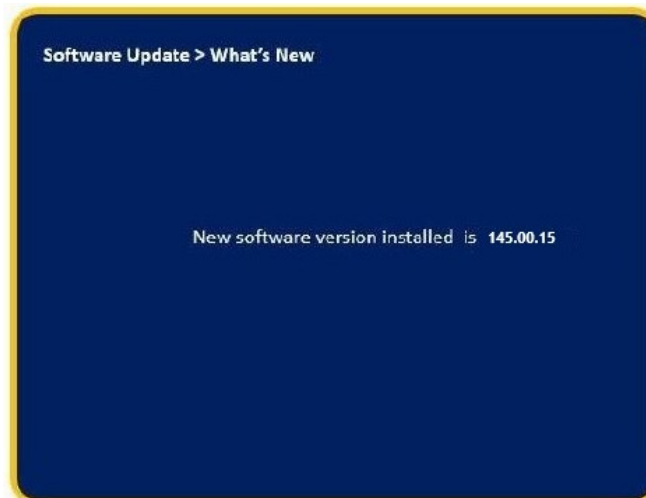
**Fig. 10**

What's New Screen

22. Select "What's new" to confirm the software has been updated to U33.43 [Fig. 10](#).
