STAR ONLINE PUBLICATION

Case Number: S2502000001

Symptom/Vehicle Issue: Lower Ball Joint / Lower Control Arm Servicing Updates.

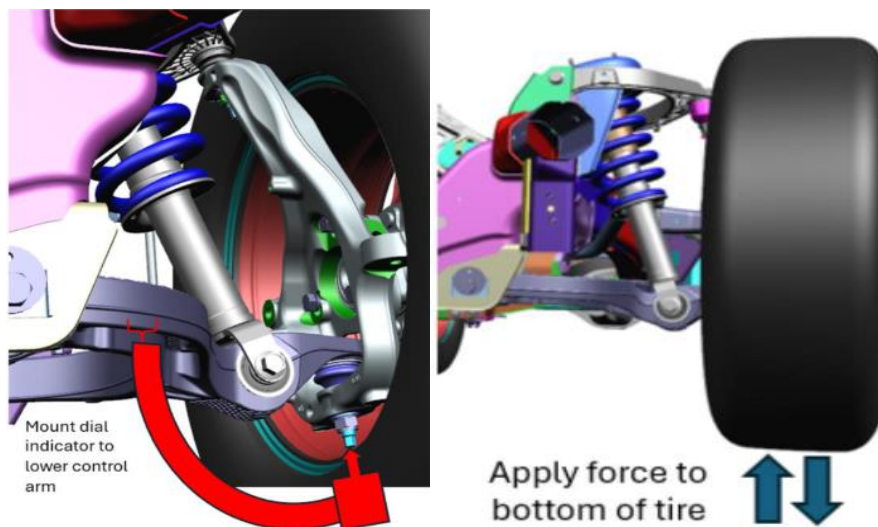
The new process includes hoisting the vehicle with the tires off the ground. Leave the wheel/tire assembly on the truck. **Installing the dial indicator is unchanged.** Using a clamp on (locking plier or c clamp style) dial indicator with a lockable flex arm locked to prevent false movement, clamp the dial indicator to the lower control arm and place the plunger against the lower ball joint stud (stud, nut or nut flange are ok) in line with the ball joint stud. **Do NOT use a prybar to take the measurement.** Instead, push/pull on the bottom of the tire by hand with the vehicle raised. Only replace the control arm if ball joint play exceeds .020" or 0.5mm, and ensure the measurement is not a result of vehicle shaking on the lift.
