## STAR ONLINE PUBLICATION

**Case Number:** S2502000002

**Symptom/Vehicle Issue:** Clunk Pop Noise From Front End While Driving.

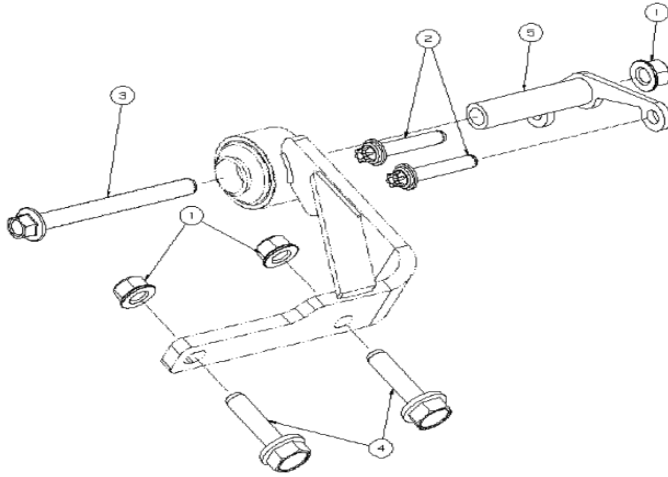
Fig 2.

Individual parts shown are in kit 68730602AB. Only order AB or newer.

<<<**NOTE**>>> Replace the mount using **68730602AB** or newer. Refer to StarPARTS for the most current part information.
