Model Series 463 AMG: Active Distance Assist and Active Brake Assist IC Message and DTC U0416FE

Topic number	LI54.71-P-078112
Version	7
Function group	54.71 - Camera and radar-assisted assistance systems
Date	12/11/25
Validity	463 AMG
Reason for change	Line connector part number update

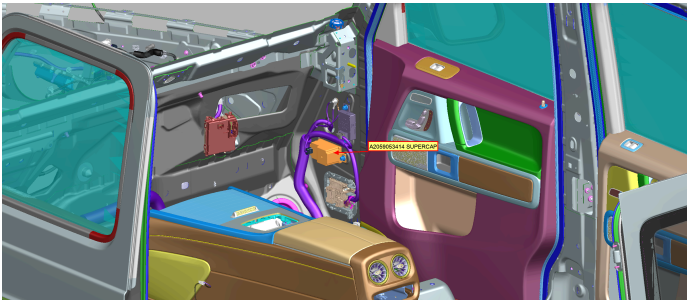
Steuergerät+SUPERCAP+Lage+im+Fzg+weit..png	Picture 1 - Connection from Supercap to Drive Unit

Missing wire between Drive Unit (N145) and Supercap (C8).

- Using a red/white cable with cross-section 0.35 mm² and overall length of approximately 2m.
- Connect Drive Unit (N145) plug A pin 18 to the 3-pin plug of the Supercap (C8) terminal 15 pin 2. Reference the new wire routing location as shown by the red line in "Picture 1 - Connection from Supercap to Drive Unit".
- The new wire should be added to the existing wiring harness as shown by the red line "Picture 1 - Connection from Supercap to Drive Unit".
- Z-Splice is the preferred method using A 000 982 91 10 for the Supercap (C8) connection.
