Service Bulletin

Bulletin No.: PIC6629B

Subject: Display Diagnostic Tips and Procedures

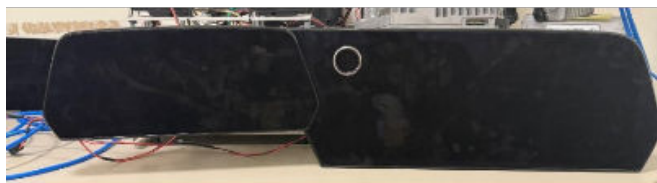
Examples of whole or both displays are blank or black.

Verify if the screen is black (appears off), or if a backlight is present on the display refer to specific procedure below based on symptom see pictures below.

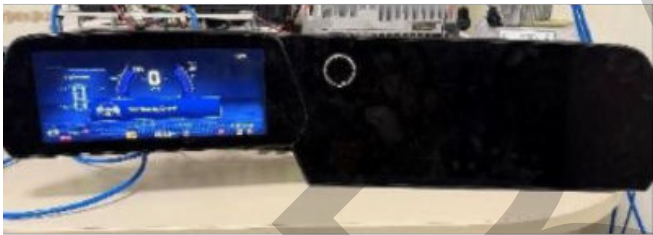
7019596

Below are examples of one, or portion of the display is blank
