Service Bulletin

Bulletin No.: PIT6465

Subject: DRL LED Strip Flickering

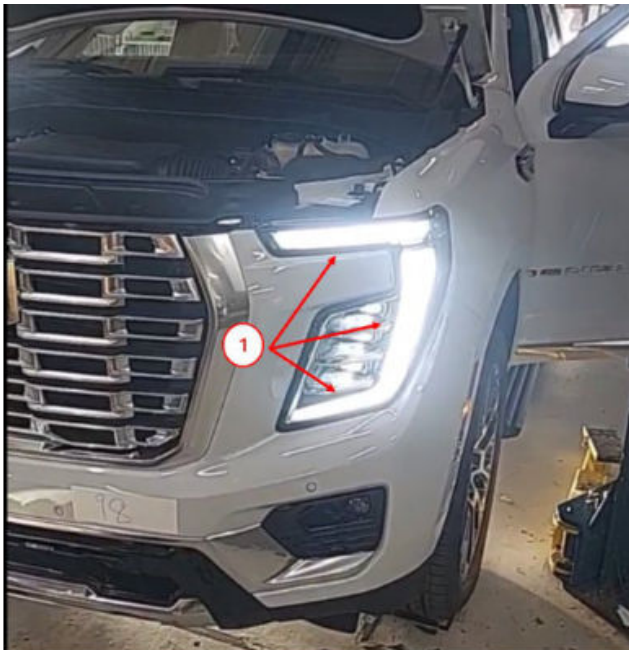
7032454

Involved Region or Country	North America
Condition	Note: This information only applies to vehicles build on or after November 19, 2025. A customer may comment that one or both headlight DRL LED strips, shown below, may intermittently flicker.
Cause	The cause of this condition may be the K219 Lighting Control Module.

DO NOT replace the headlamp assemblies for this condition.

After the concern is confirmed inspect the part number of the lighting control module in the vehicle. If the vehicle has one of the following p/n's: 13572175, 13572177, or 13572179, then replace the K219 Lighting Control Module with part number 13566314.
