HYUNDAI
Technical Service Bulletin

GROUP BODY ELECTRICAL	NUMBER 25-BE-022H
DATE DECEMBER 2025	MODEL(S) IONIQ 6 (CE EV)

SUBJECT: INOPERATIVE HORN ASSEMBLY REPLACEMENT
(WARRANTY EXTENSION Z13)

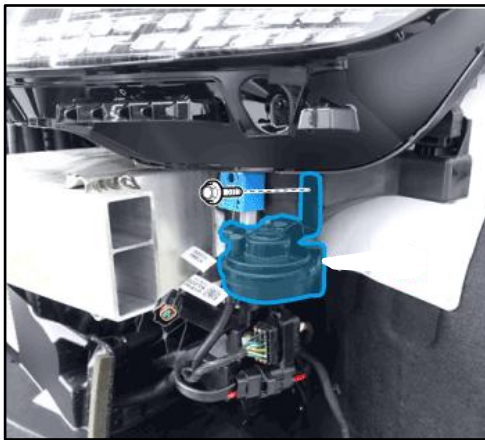
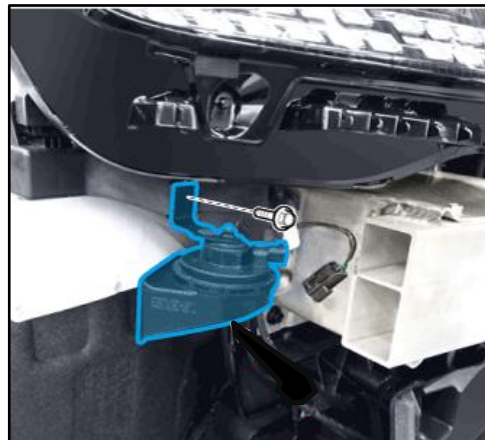
Description: Certain IONIQ 6 (CE EV) vehicles may have an inoperable horn that may be caused by water intrusion through the ventilation hole.

This bulletin provides instructions on the replacement of the inoperative horn.
