Technical Service Bulletin

| GROUP SUSPENSION | NUMBER 25-SS-004H |
| DATE DECEMBER 2025 | MODEL(S) PALISADE (LX2) |

SUBJECT: SELF-LEVELING REAR SHOCK ABSORBER CLUNKING/THUMPING NOISE ON ROUGH ROADS (WARRANTY EXTENSION Z12)

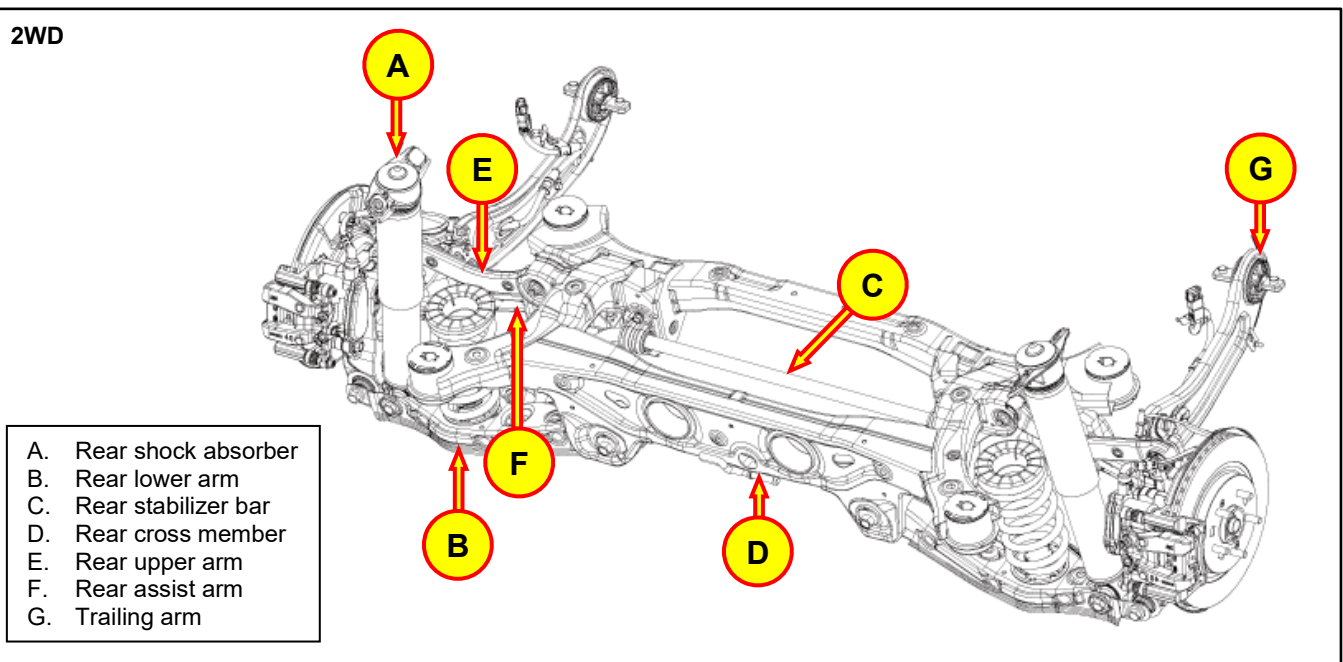
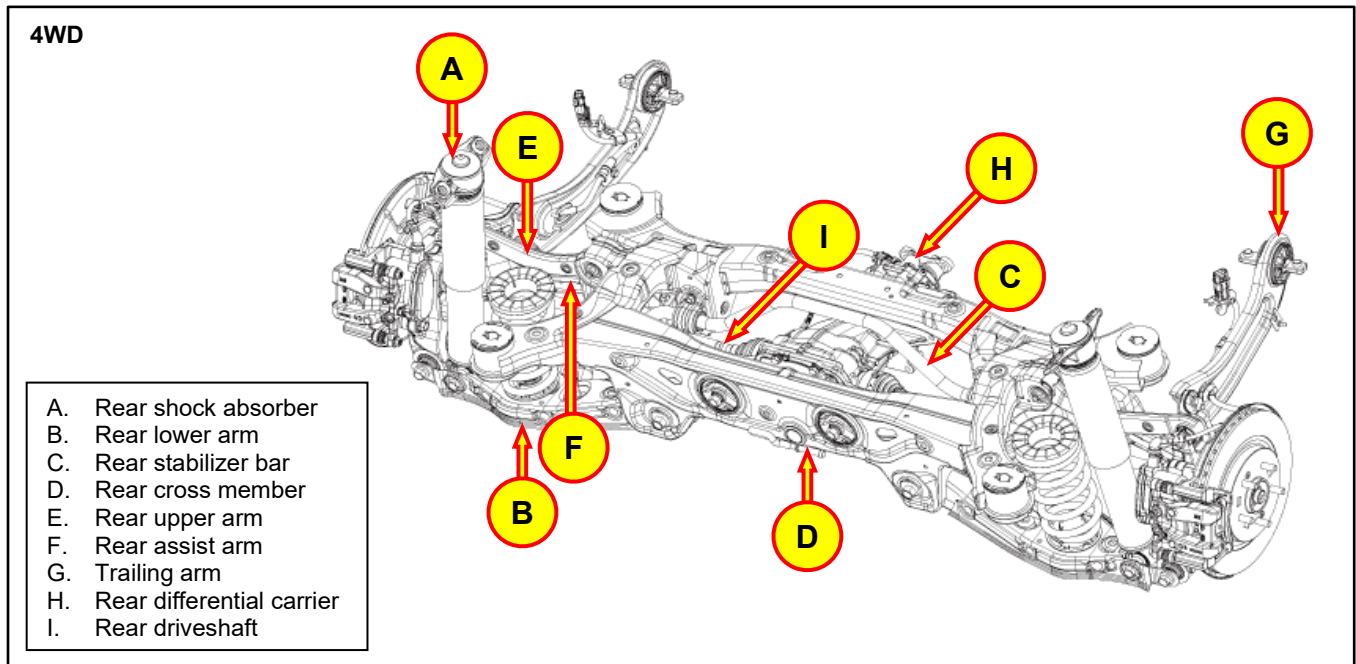
3. Visually inspect the rear suspension components listed below for visible damage.

- **NO DAMAGE:** Proceed to [Shock Absorber Replacement](#).
- **DAMAGE:** Follow the normal diagnostic process and repair as necessary. Test drive and verify if a clunk or thump noise is present from the rear of the vehicle.
 - **NO NOISE:** If the noise is resolved, then the service procedure is complete.
 - **NOISE:** If the noise is still present, proceed to [Shock Absorber Replacement](#).

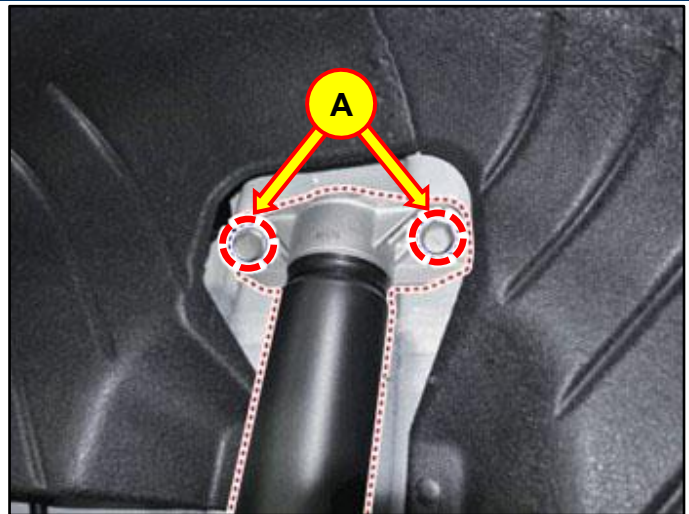
Description: Certain Palisade (LX2) vehicles may exhibit a clunking or thumping noise from the rear of the vehicle while driving over rough roads. This may be caused by worn self-leveling rear shock absorbers.

1. Install the new rear shock absorbers on both sides of the vehicle.

Tightening Torque - Shock Absorber Mounting Bolts (A):

| lb-ft | 94 |
| N.m | 127 |
