STAR ONLINE PUBLICATION

Case Number: S2523000093

Symptom/Vehicle Issue: Buzz Squeak Rattle (BSR) Vibration From Under Vehicle While Driving.

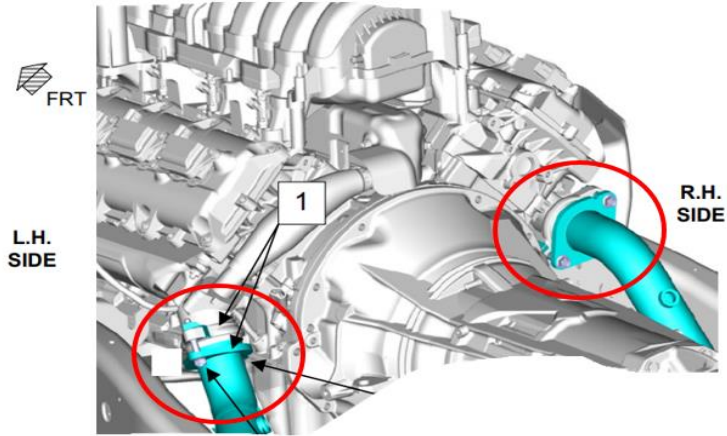
Fig 1.

Discussion: Inspect the exhaust Y-pipe clearance to the transfer case crossmember. The ideal gap between the Y-pipe assembly and the crossmember is 7/16" - 3/4" (12mm-19mm). If there is little or no gap, see the below procedure to correct the concern.

1. Loosen, but do not remove, the exhaust manifold to Y-pipe fasteners to allow "free" movement in the exhaust joints. (Fig 1)
