CAN-AM ON-ROAD 2025-5 Canyon Saddle Bags Watertightness Improvement

Vehicle - Quality Bulletin

December 18, 2025
Bulletin 2025-5 | Version A
Campaign N° 2025-0005

Canyon Saddle Bags Watertightness Improvement

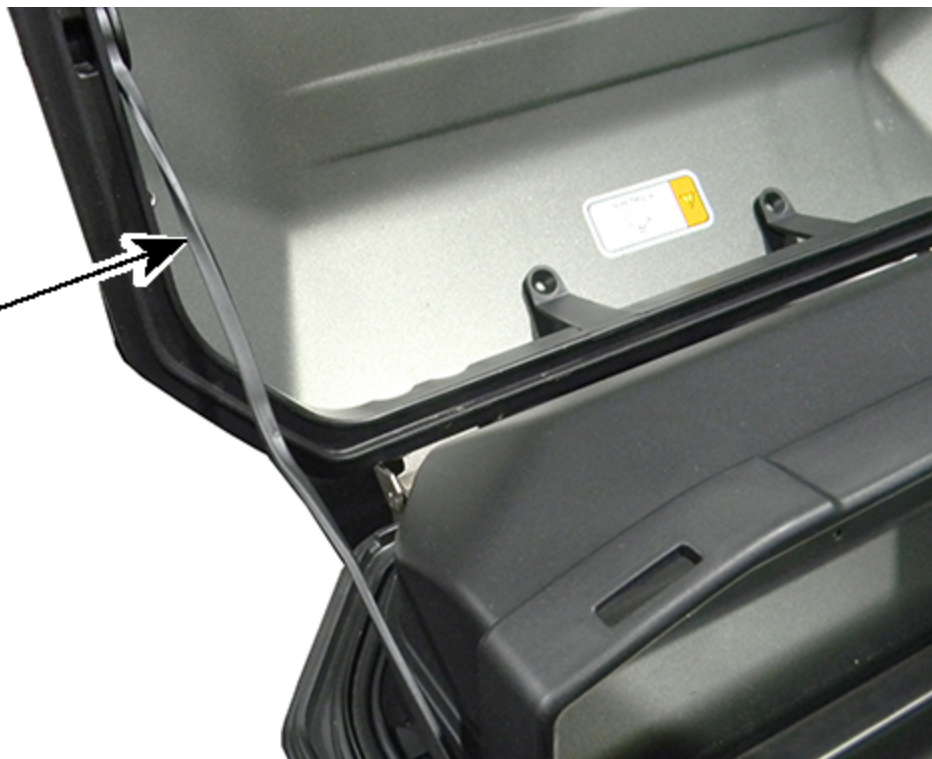
When closing the cover, make sure the straps are not twisted, they can be untwisted by turning around their pivot points. If the straps are twisted, they will tend to fold over the cover seal and prevent proper water tightness.

1. Avoid twisted strap
