Service Bulletin

Bulletin No.: PIP6033A

Subject: CVT Transmission Noise - Slip or Loss of Motion

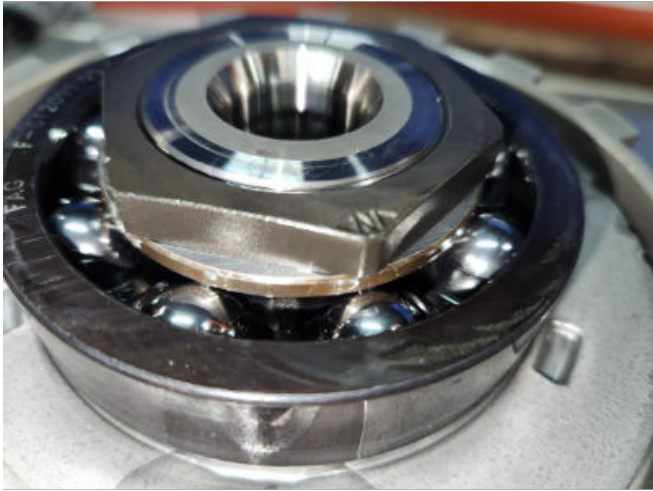
6781798

There have been issues seen with spalling on the bearing race as seen below.

Please follow the appropriate process to obtain and replace the transmission.

If there is damage present to the Tapered roller bearings on the final drive or the transfer gear these bearings and races can be replaced without transmission replacement

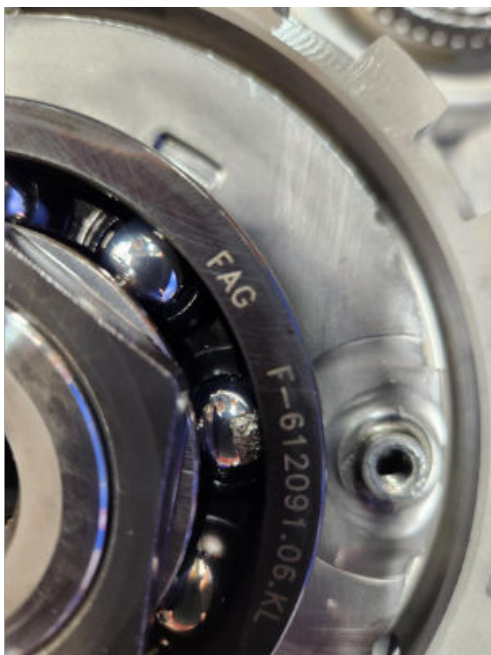
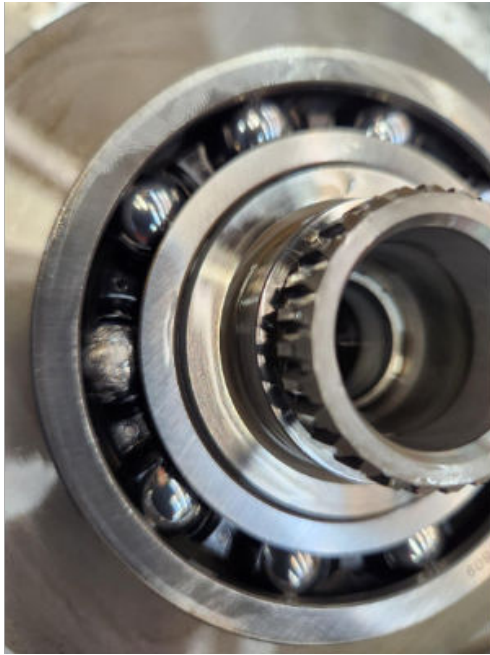
There have also been issues with the ball bearings having spalling on them as well as seen in the examples below.
