# Service Bulletin

Bulletin No.: PIC6633

**Subject: Door Window Bind, Reversal or Incomplete Motion and Possible Noises**

Brand:	Model:	Model Year:		VIN:		Engine:	Transmission:
		from	to	from	to		
Cadillac	OPTIQ	2025 - 2026		All	All	All	All

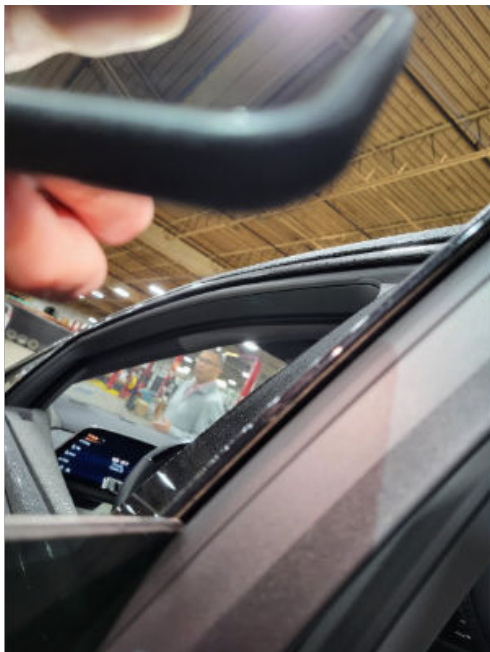
7012541

This image shows the window positioned correctly in the seal.

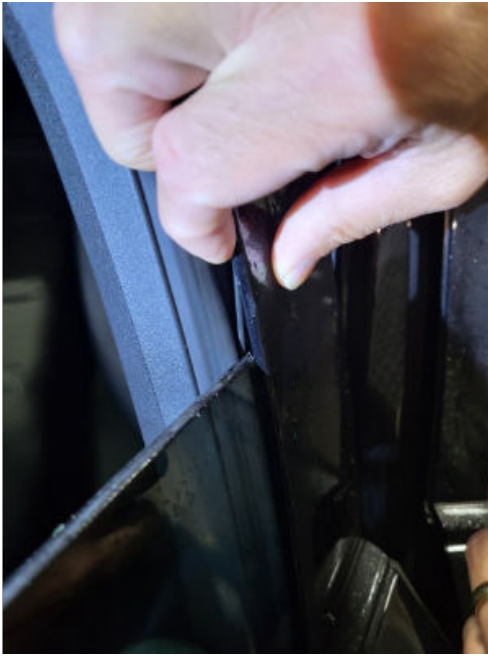
7012540

This image shows the window positioned on the outboard side of the seal.

If the window is located on the wrong side of the seal, the technician will need to lower the glass to the full down position and then pull the lower portion of the seal out from the applique, then reinstalling it properly so the glass is INBOARD of the outmost seal lip.
