**Technical Service Bulletin (TSB)**  
**Flash: Motor Control Processor A (MCP A) Updates 11B3**

<b>REFERENCE:</b>	<b>TSB:</b> 08-010-25 REV. E <b>GROUP:</b> 08 - Electrical	<b>Date:</b>	December 18, 2025	<b>REVISION:</b>	08-010-25 REV. D
<b>VEHICLES AFFECTED:</b>	<b>2024 (KM) Jeep Wagoneer S</b> This bulletin applies to vehicles equipped with 400V G2500 FR/RR Elec Drive Motors (Sales Code ELD).			<b>MARKET APPLICABILITY:</b> <input checked="" type="checkbox"/> NA <input type="checkbox"/> MEA <input type="checkbox"/> SA <input type="checkbox"/> IAP <input type="checkbox"/> EE <input type="checkbox"/> CH <b>NOTE:</b> This bulletin applies to the North America market.	
<b>CUSTOMER SYMPTOM:</b>	<p><b>Customers may experience a Malfunction Indicator Lamp (MIL) illumination and the vehicle may exhibit/set the following Diagnostic Trouble Code (DTC):</b></p> <ul style="list-style-type: none"> <li>• **P1E18-00 - Internal Control Module Electronic Park Performance.</li> <li>• P1625-00 - Park Pawl System Failure.</li> <li>• P0A78-00 - Drive Motor A Inverter Performance.</li> <li>• P0A79-00 - Drive Motor B Inverter Performance.**</li> <li>• P1626-00 - Park Pawl Motor Stuck.</li> </ul> <p><b

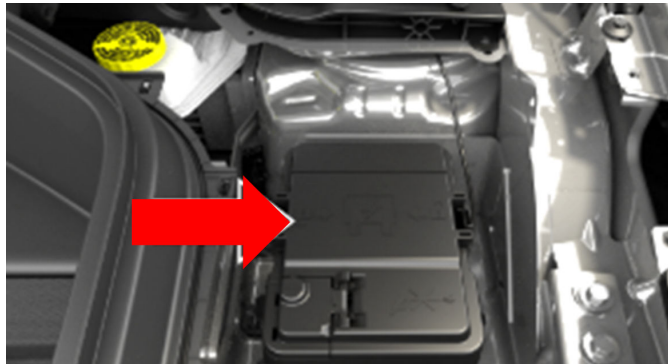
**Fig. 2**  
Front PDC Cover

**\*\*Failure to remove the #32 AGSM/GSM fuse will result in damage to the shifter.**

5. Remove the front PDC cover, locate and remove the #32 AGSM/GSM fuse [Fig. 2\\*\\*](#).

33. \*\*Install the #32 AGSM/GSM fuse and the front PDC cover [Fig. 2](#)\*\*.
