<b>REFERENCE:</b>	<b>TSB:</b> 08-011-25 REV. D <b>GROUP:</b> 08 - Electrical	<b>Date:</b>	December 18, 2025	<b>REVISION:</b>	08-011-25 REV. C
<b>VEHICLES AFFECTED:</b>	<b>2024 (KM) Jeep Wagoneer S</b> <b>This bulletin applies to vehicles equipped with 400V G2500 FR/RR Elec Drive Motors (Sales Code ELD).</b>			<b>MARKET APPLICABILITY:</b> <input checked="" type="checkbox"/> NA <input type="checkbox"/> MEA <input type="checkbox"/> SA <input type="checkbox"/> IAP <input type="checkbox"/> EE <input type="checkbox"/> CH <b>NOTE: This bulletin applies to the North America market.</b>	
<b>CUSTOMER SYMPTOM:</b>	<p><b>Customers may experience a Malfunction Indicator Lamp (MIL) illumination and the vehicle may exhibit/set one or more of the following Diagnostic Trouble Codes (DTCs):</b></p> <ul style="list-style-type: none"> <li>● **P1E25 - EV Battery Failure Level 2</li> <li>● P0D10 - Battery Charging System Negative Contactor "A" - Actuator Stuck Open</li> <li>● P0D09 - Battery Charging System Positive Contactor "A" - Actuator Stuck Open**</li> <li>● P0DE6 - Hybrid/EV Battery Pack Cell Voltage Low.</li> </ul> <p><b>NOTE: Active or stored.</b></p> <ul style="list-style-type: none"> <li>● P1

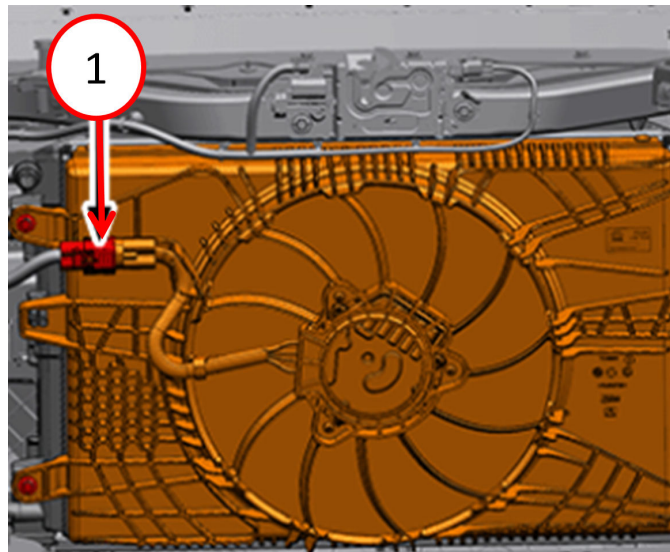
**Fig. 1**  
Cooling Fan Assembly

**NOTE: The cooling fan must be disconnected to prevent it from powering on, which may interrupt/ abort the flash process.**

1 - Wire Harness To Disconnect/Connect

4. Disconnect the cooling fan wire harness connector [Fig. 1](#).

34. Connect the cooling fan wire harness connector [Fig. 1](#).

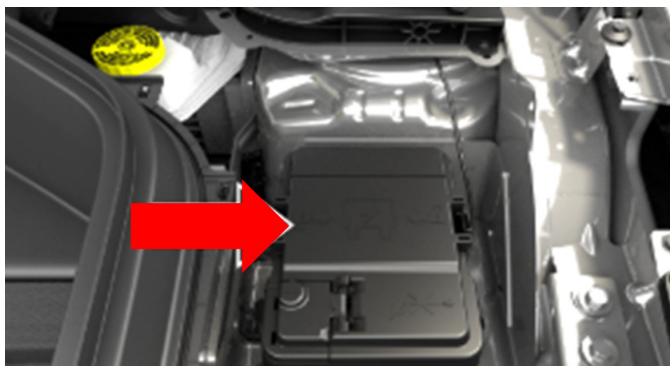
**Fig. 2**  
Front PDC Cover

**\*\*Failure to remove the #32 AGSM/GSM fuse will result in damage to the shifter.**

- Remove the front PDC cover, locate and remove the #32 AGSM/GSM fuse [Fig. 2](#)\*\*.

33. \*\*Install the #32 AGSM/GSM fuse and the front PDC cover [Fig. 2](#)\*\*.
