REFERENCE:	TSB: 08-014-25 REV. E GROUP: 08 - Electrical	Date:	December 18, 2025	REVISION:	08-014-25 REV. D
VEHICLES AFFECTED:	2024 (KM) Jeep Wagoneer S This bulletin applies to vehicles equipped with 400V G2500 FR/RR Elec Drive Motors (Sales Code ELD).			MARKET APPLICABILITY: <input checked="" type="checkbox"/> NA <input type="checkbox"/> MEA <input type="checkbox"/> SA <input type="checkbox"/> IAP <input type="checkbox"/> EE <input type="checkbox"/> CH NOTE: This bulletin applies to the North America market.	
CUSTOMER SYMPTOM:	<p>Customers may experience a Malfunction Indicator Lamp (MIL) illumination and the vehicle may exhibit/set one or more of the following Diagnostic Trouble Codes (DTCs):</p> <ul style="list-style-type: none"> ● **B12B4-00 - Charge Status Indicator Module Internal.** ● C10FA-00 - Wheel Hub disconnect Actuator Performance Left. ● C10FB-00 - Wheel Hub disconnect Actuator Performance Right. ● C10F8-00 - Left Front Wheel Hub Disconnect Actuator Position Sensor Circuit Range/Performance. ● C10F9-00 - Right Front Wheel Hub Disconnect Actuator Position Sensor Circuit Range/Performance. ● P061B-00 - Internal Control Module Torque Calculation Performance. <p>Customers

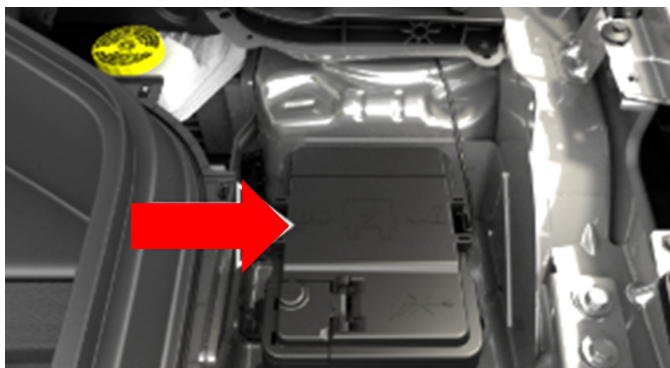
Fig. 2
Front PDC Cover

****Failure to remove the #32 AGSM/GSM fuse will result in damage to the shifter.**

- Remove the front PDC cover, locate and remove the #32 AGSM/GSM fuse [Fig. 2](#)**.

33. **Install the #32 AGSM/GSM fuse and the front PDC cover [Fig. 2](#)**.
