Technical Service Bulletin (TSB)
RSU With Additional Sleep Cycles for HV Battery Integrity Check
- Flash: Battery Pack Control Module (BPCM) Updates 11B3

REFERENCE:	TSB: 08-076-25 REV. D GROUP: 08 - Electrical	Date:	December 18, 2025	REVISION:	08-076-25 REV. C
VEHICLES AFFECTED:	2024 (KM) Jeep Wagoneer S This bulletin applies to vehicles equipped with 400V G2500 FR/RR Elec Drive Motors (Sales Code ELD).			MARKET APPLICABILITY: <input checked="" type="checkbox"/> NA <input type="checkbox"/> MEA <input type="checkbox"/> SA <input type="checkbox"/> IAP <input type="checkbox"/> EE <input type="checkbox"/> CH NOTE: This bulletin applies to the North America market.	
CUSTOMER SYMPTOM:	<p>Customers may experience a Malfunction Indicator Lamp (MIL) illumination and the vehicle may exhibit/set one or more of the following Diagnostic Trouble Codes (DTCs):</p> <ul style="list-style-type: none"> ● **P1E25-00 - EV Battery Failure Level 2. ● P0D10-00 - Hybrid/EV Battery Negative Contactor A Stuck Open. ● P0D09-00 - Hybrid/EV Battery Positive Contactor A Stuck Open.** ● P0DE6 - Hybrid/EV Battery Pack Cell Voltage Low. <p>NOTE: Active or stored.</p> <ul style="list-style-type: none"> ● P1DAF - In

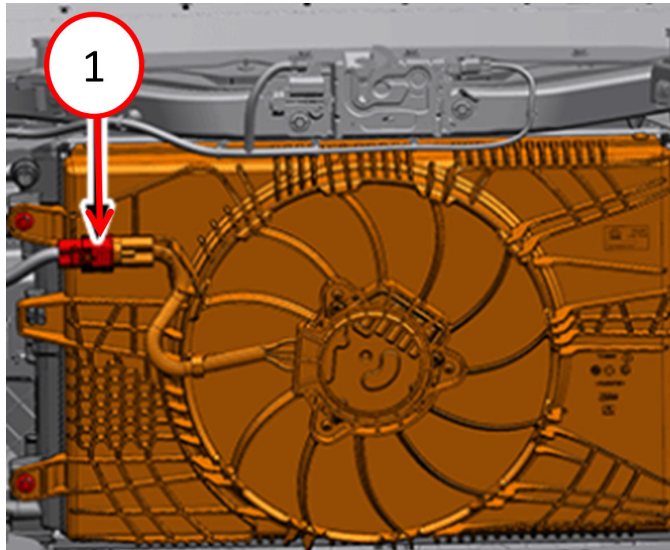
Fig. 1
Cooling Fan Assembly

NOTE: The cooling fan must be disconnected to prevent it from powering on, which may interrupt/ abort the flash process.

1 - Wire Harness To Disconnect/Connect

4. Disconnect the cooling fan wire harness connector [Fig. 1](#).

33. **Install the #32 AGSM/GSM fuse and the front PDC cover [Fig. 2](#)**.
34. Connect the cooling fan wire harness connector [Fig. 1](#).

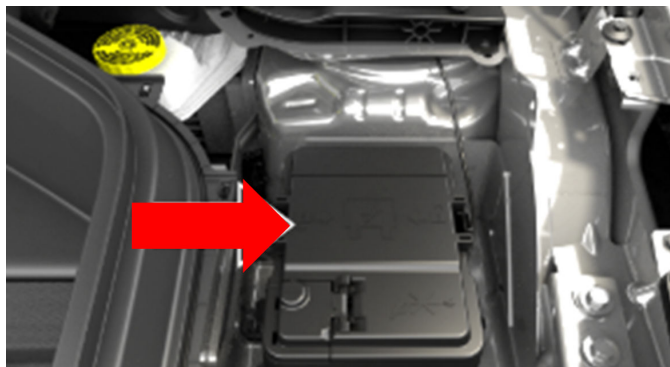
Fig. 2
Front PDC Cover

****Failure to remove the #32 AGSM/GSM fuse will result in damage to the shifter.****

5. Remove the front PDC cover, locate and remove the #32 AGSM/GSM fuse [Fig. 2](#)**.
