<b>REFERENCE:</b>	<b>TSB:</b> 08-127-25 REV. C <b>GROUP:</b> 08 - Electrical	<b>Date:</b>	December 18, 2025	<b>REVISION:</b>	08-127-25 REV. B
<b>VEHICLES AFFECTED:</b>	<b>2025 (KM) Jeep Wagoneer S</b> This bulletin applies to vehicles equipped with 400V G2500 FR/RR Elec Drive Motors (Sales Code ELD).			<b>MARKET APPLICABILITY:</b> <input checked="" type="checkbox"/> NA <input type="checkbox"/> MEA <input type="checkbox"/> SA <input type="checkbox"/> IAP <input type="checkbox"/> EE <input type="checkbox"/> CH  <b>NOTE: **This bulletin applies to North America markets.**</b>	
<b>CUSTOMER SYMPTOM:</b>	<p><b>Customers may experience a Malfunction Indicator Lamp (MIL) illumination and the vehicle may exhibit/set one or more of the following Diagnostic Trouble Codes (DTCs):</b></p> <ul style="list-style-type: none"> <li>● <b>**B12B4-00 - Charge Status Indicator Module Internal.**</b></li> <li>● C10FA-00 - Wheel Hub disconnect Actuator Performance Left.</li> <li>● C10FB-00 - Wheel Hub disconnect Actuator Performance Right.</li> <li>● C10F8-00 - Left Front Wheel Hub Disconnect Actuator Position Sensor Circuit Range/Performance.</li> <li>● C10F9-00 - Right Front Wheel Hub Disconnect Actuato

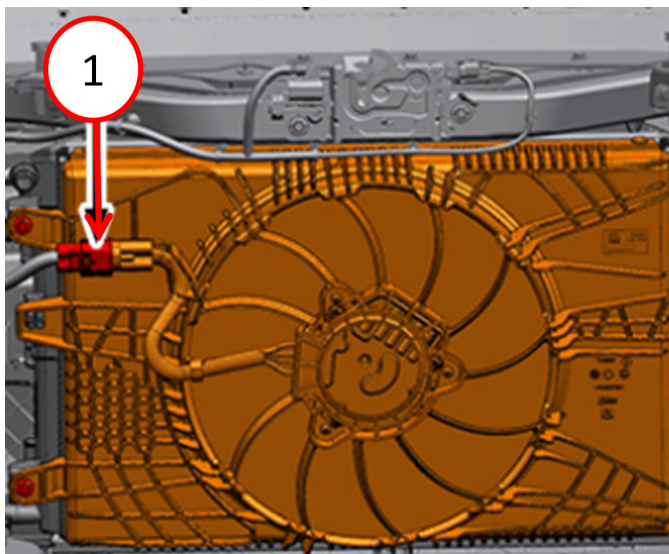
**Fig. 1**  
Cooling Fan Assembly

**NOTE: The cooling fan must be disconnected to prevent it from powering on, which may interrupt/ abort the flash process.**

1 - Wire Harness To Disconnect/Connect

4. Disconnect the cooling fan wire harness connector [Fig. 1](#).

34. Connect the cooling fan wire harness connector [Fig. 1](#).

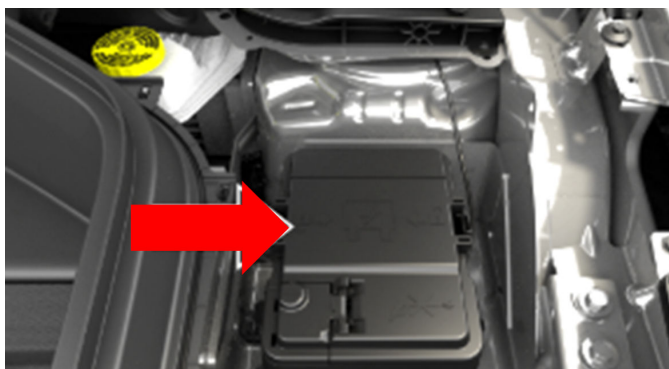
**Fig. 2**  
Front PDC Cover

**\*\*Failure to remove the #32 AGSM/GSM fuse will result in damage to the shifter.\*\***

5. Remove the front PDC cover, locate and remove the #32 AGSM/GSM fuse [Fig. 2](#)**\*\***.

33. \*\*Install the #32 AGSM/GSM fuse and the front PDC cover [Fig. 2](#)\*\*.
