REFERENCE:	TSB: 08-128-25 REV. B GROUP: 08 - Electrical	Date:	December 18, 2025	REVISION:	08-128-25 REV. A
VEHICLES AFFECTED:	2025 (KM) Jeep Wagoneer S This bulletin applies to vehicles equipped with 400V G2500 FR/RR Elec Drive Motors (Sales Code ELD).			MARKET APPLICABILITY: <input checked="" type="checkbox"/> NA <input type="checkbox"/> MEA <input type="checkbox"/> SA <input type="checkbox"/> IAP <input type="checkbox"/> EE <input type="checkbox"/> CH NOTE: **This bulletin applies to the North America markets.**	
CUSTOMER SYMPTOM:	<p>Customers may experience a Malfunction Indicator Lamp (MIL) illumination and the vehicle may exhibit/set one or more the following Diagnostic Trouble Codes (DTCs):</p> <ul style="list-style-type: none"> ● **P0CA6-00 - Hybrid/EV Battery Charging Current High. ● P1E25-00 - EV Battery Failure Level 2. ● P0D09-00 - Battery Charging System Positive Contactor "A" - Actuator Stuck Open. ● P0D10-00 - Battery Charging System Negative Contactor "A" - Actuator Stuck Open. ● P0AA7-00 - Hybrid/EV Battery Pack "A" Voltage Isolation Sensor. ● P1614-00 - ECU Reset/Recovery Occurred. ● B1A8A-00 - Multi-Module VIN Handshake Failure. ● P1CDB-00 - Hybrid/EV Wakeup Contr

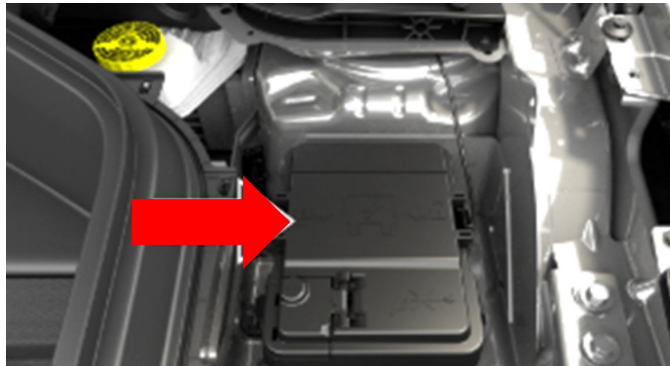
Fig. 2
Front PDC Cover

****Failure to remove the #32 AGSM/GSM fuse will result in damage to the shifter.**

- 5. Remove the front PDC cover, locate and remove the #32 AGSM/GSM fuse [Fig. 2**](#).

33. **Install the #32 AGSM/GSM fuse and the front PDC cover [Fig. 2](#)**.
34. Connect the cooling fan wire harness connector [Fig. 1](#).
35. Install the front storage bin. Refer to the detailed service procedures available in DealerCONNECT/ServiceLibrary under: Service Info> 23 - Body / Exterior / Bin, Storage / Installation.
36. Clear any DTCs that may have been set in any modules due to reprogramming. The wiTECH application will automatically present all DTCs after the flash and allow them to be cleared.
