Technical Service Bulletin (TSB)

RSU With Additional Sleep Cycles for HV Battery Integrity Check - Flash: Integrated Dual Charging Module (IDCM) Updates 11B3

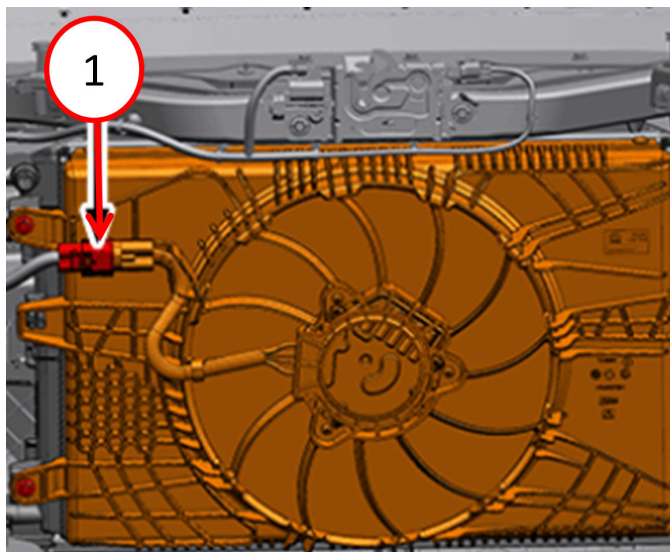
Fig. 1
Cooling Fan Assembly

NOTE: The cooling fan must be disconnected to prevent it from powering on, which may interrupt/ abort the flash process.

1 - Wire Harness To Disconnect/Connect

4. Disconnect the cooling fan wire harness connector [Fig. 1](#).

34. Connect the cooling fan wire harness connector [Fig. 1](#).

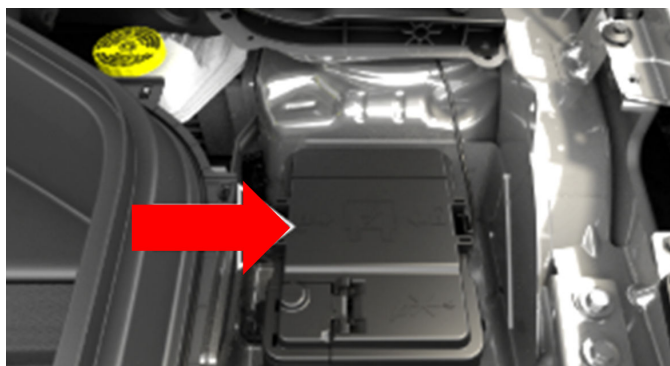
Fig. 2
Front PDC Cover

****Failure to remove the #32 AGSM/GSM fuse will result in damage to the shifter.****

5. Remove the front PDC cover, locate and remove the #32 AGSM/GSM fuse [Fig. 2](#)**.

33. **Install the #32 AGSM/GSM fuse and the front PDC cover [Fig. 2](#)**.
