REFERENCE:	TSB: 08-407-25 GROUP: 08 - Electrical	Date:	December 18, 2025	REVISION:	–
VEHICLES AFFECTED:	2023 (WL) Jeep Grand Cherokee / Grand Cherokee L			MARKET APPLICABILITY: <input type="checkbox"/> NA <input type="checkbox"/> MEA <input type="checkbox"/> SA <input type="checkbox"/> IAP <input type="checkbox"/> EE <input checked="" type="checkbox"/> CH NOTE: This bulletin applies to China markets.	
CUSTOMER SYMPTOM:	Customers may experience the following: <ul style="list-style-type: none"> Vehicle no start due to a depleted 12V battery. 				
CAUSE:	Loose PDC connector pin

This bulletin involves inspecting the PDC C3 connector for improperly installed pins and correcting the connector pins if found to be installed backwards.

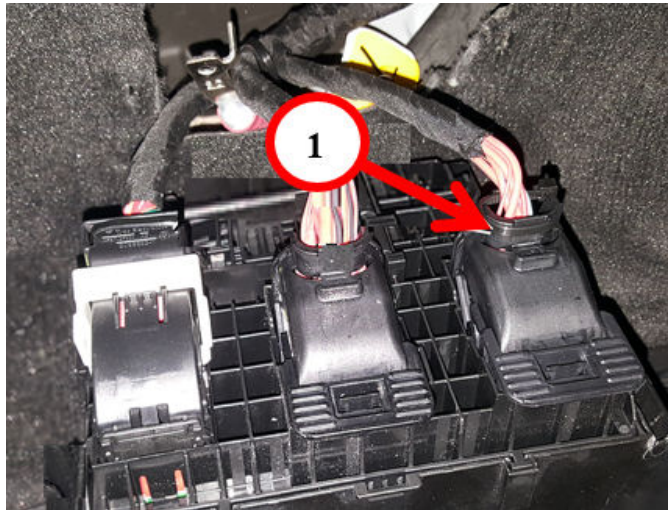
Fig. 3
PDC C3 Connector

- 1 - Disconnect C3 Connector

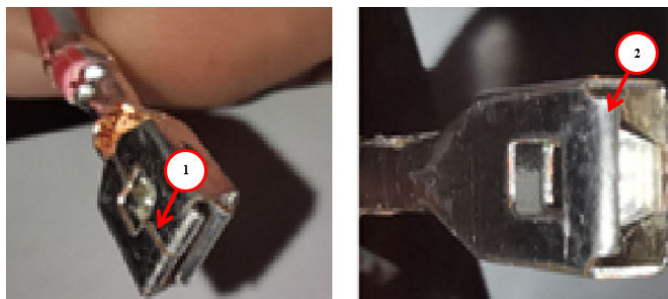
Fig. 6

Pin Inspection

- 1 - Seam Visible - Indicates Incorrect Alignment
- 2 - Rolled Edge - Indicates Correct Alignment

9. Was a seam noticed when inspect the large and medium pins [Fig. 6](#)?
 - YES>>> Proceed to [Step 10](#).
 - NO>>> Proceed to [Step 11](#).
10. If you can see a seam between the large and medium pins on this connector, it means that the pin installation is incorrect. The pins need to be rotated 180 degrees prior to installing them back to the connector.

11. For the smallest pin, gently pull the wire from the backside of the connector to check if it's loose. Secure as needed.
12. Correctly align and install the large and medium pins back to the connector.
