REFERENCE:	TSB: 08-409-25 GROUP: 08 - Electrical	Date:	December 18, 2025	REVISION:	—
VEHICLES AFFECTED:	2025 (KM) Wagoneer S This bulletin applies to vehicles equipped with 400V G2500 FR/RR Elec Drive Motors (Sales Code ELD).			MARKET APPLICABILITY:	<input checked="" type="checkbox"/> NA <input type="checkbox"/> MEA <input type="checkbox"/> SA <input type="checkbox"/> IAP <input type="checkbox"/> EE <input type="checkbox"/> CH NOTE: This bulletin applies to North America markets.
CUSTOMER SYMPTOM:	<p>Customers may experience a Malfunction Indicator Lamp (MIL) illumination and the vehicle may exhibit/set one or more of the following Diagnostic Trouble Codes (DTCs):</p> <ul style="list-style-type: none"> • P1E18-00 - Internal Control Module Electronic Park Performance. • P1625-00 - Park Pawl System Failure. • P1626-00 - Park Pawl Motor Stuck. <p>NOTE: If DTCs P1E25-00, P1625-00 or P1626-00 are active, the vehicle will stay in READY mode since the Electric Vehicle Control Unit (EVCU) is not able to confirm if the park pawl is engaged, and the vehicle will be secured.</p> <ul style="list-style-type: none"> • P0A78-00 - Drive Motor A Inverter Performance. • P0A79-00 - Drive Motor B Inve

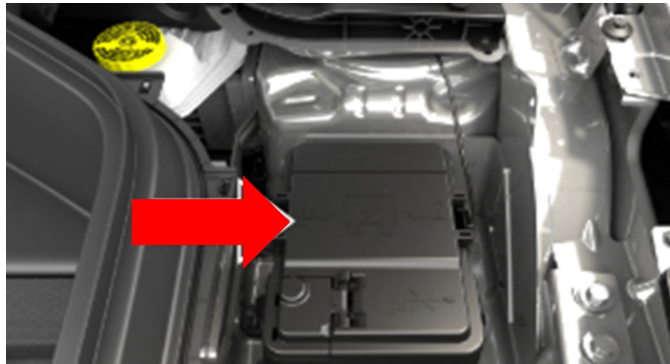
Fig. 2
Front PDC Cover

Failure to remove the #32 AGSM/GSM fuse will result in damage to the shifter.

5. Remove the front PDC cover, locate and remove the #32 AGSM/GSM fuse [Fig. 2](#).

33. Install the #32 AGSM/GSM fuse and the front PDC cover [Fig. 2](#).
