<b>REFERENCE:</b>	<b>TSB:</b> 08-410-25 <b>GROUP:</b> 08 - Electrical	<b>Date:</b>	December 18, 2025	<b>REVISION:</b>	—
<b>VEHICLES AFFECTED:</b>	<b>2025 (KM) Jeep Wagoneer S</b> This bulletin applies to vehicles equipped with 400V G2500 FR/RR Elec Drive Motors (Sales Code ELD).			<b>MARKET APPLICABILITY:</b> <input checked="" type="checkbox"/> NA <input type="checkbox"/> MEA <input type="checkbox"/> SA <input type="checkbox"/> IAP <input type="checkbox"/> EE <input type="checkbox"/> CH <b>NOTE:</b> This bulletin applies to the North America markets.	
<b>CUSTOMER SYMPTOM:</b>	<p>Customers may experience a Malfunction Indicator Lamp (MIL) illumination and the vehicle may exhibit/set one or more of the following Diagnostic Trouble Codes (DTCs):</p> <ul style="list-style-type: none"> <li>• P1E18-00 - Internal Control Module Electronic Park Performance.</li> <li>• P1625-00 - Park Pawl System Failure.</li> <li>• P1626-00 - Park Pawl Motor Stuck.</li> </ul> <p><b>NOTE:</b> If DTCs P1E25-00, P1625-00 or P1626-00 are active, the vehicle will stay in READY mode since the Electric Vehicle Control Unit (EVCU) is not able to confirm if the park pawl is engaged, and the vehicle will be secured.

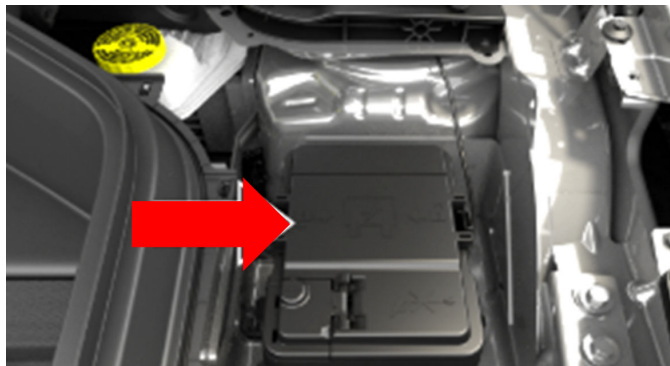
**Fig. 2**  
Front PDC Cover

**Failure to remove the #32 AGSM/GSM fuse will result in damage to the shifter.**

5. Remove the front PDC cover, locate and remove the #32 AGSM/GSM fuse [Fig. 2](#).

33. Install the #32 AGSM/GSM fuse and the front PDC cover [Fig. 2](#).
