GROUP	MODEL
ELE	2025MY EV6 (CVa) <u>and</u> 2026 EV9 (MVa)
NUMBER	DATE
409	December 2025

TECHNICAL SERVICE BULLETIN

SERVICE ACTION: INTEGRATED CHARGE CONTROLLER UNIT REPLACEMENT (SA639)

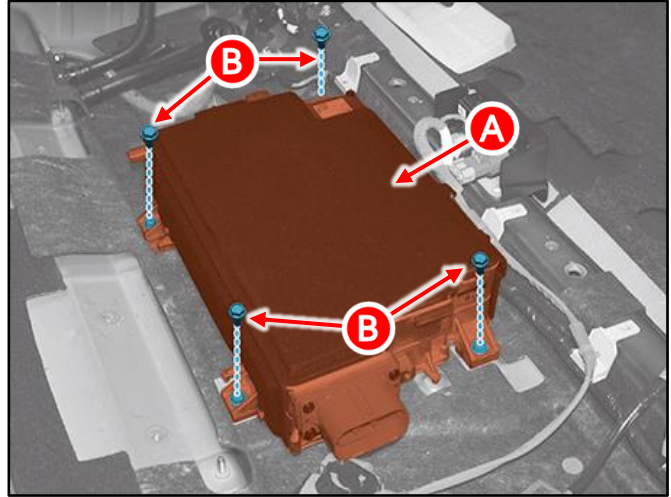
Repair Procedure For EV6 (CVa):

This bulletin provides instructions for replacing the Integrated Charge Controller Unit (ICCU) on certain 2025 model year EV6 (CVa) and 2026 EV9 (MVa) vehicles produced between February 21, 2025, and September 18, 2025. Affected vehicles may exhibit Diagnostic Trouble Code (DTC) P2E9092 related to the Battery Charger "A" Internal Power Supply, resulting in an inability to charge under Level 1 or Level 2 conditions. Follow the procedure in this bulletin to replace the ICCU on applicable vehicles. Before performing the repair, confirm that the vehicle is included in the affected VIN list.

1. Replace the ICCU (A) by referring to "High Voltage Charging System → Integrated Control Unit (ICCU) → Removal and Installation Repair procedures" in the applicable Shop Manual on KGIS.

Tightening torque for ICCU Case to Body Bolts (B): 14.5 - 17.3 lb.ft (19.6 - 23.5 N.m)
