Tesla, Inc.
Service Bulletin

Replace AC Junction Box to Fast Charge Contactor HV Harness

SB-25-16-006

December 8, 2025

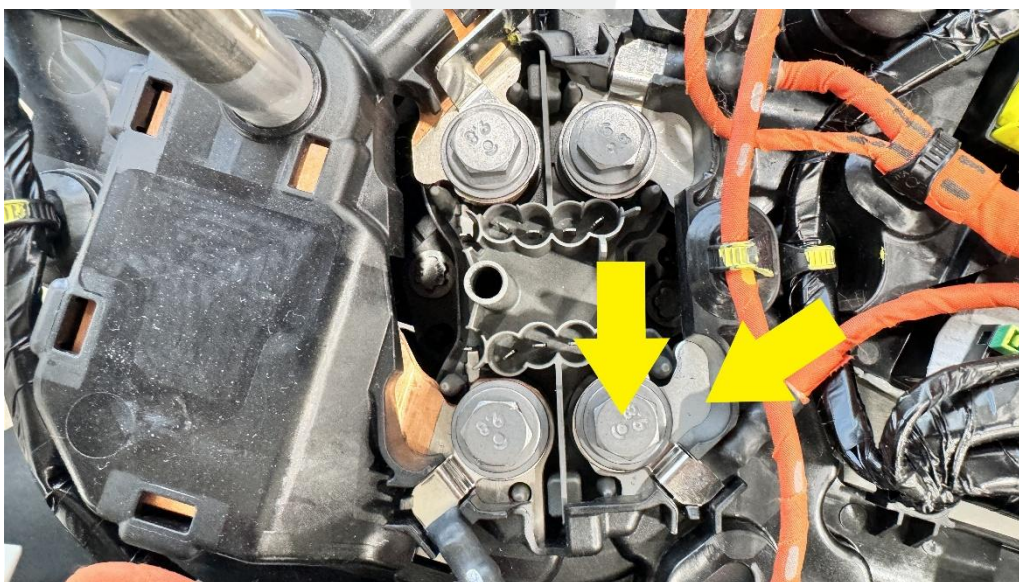
Figure 5

**NOTE:** The results of the measurement should be $102\mu\Omega$ or fewer. If the results are greater than $102\mu\Omega$, continue with general diagnosis outside of this bulletin.

6. Perform a zero adjust to the Hioki meter, and then perform a Hioki impedance measurement at the FC contactor positive joint to positive DC outlet busbar (Figure 5).

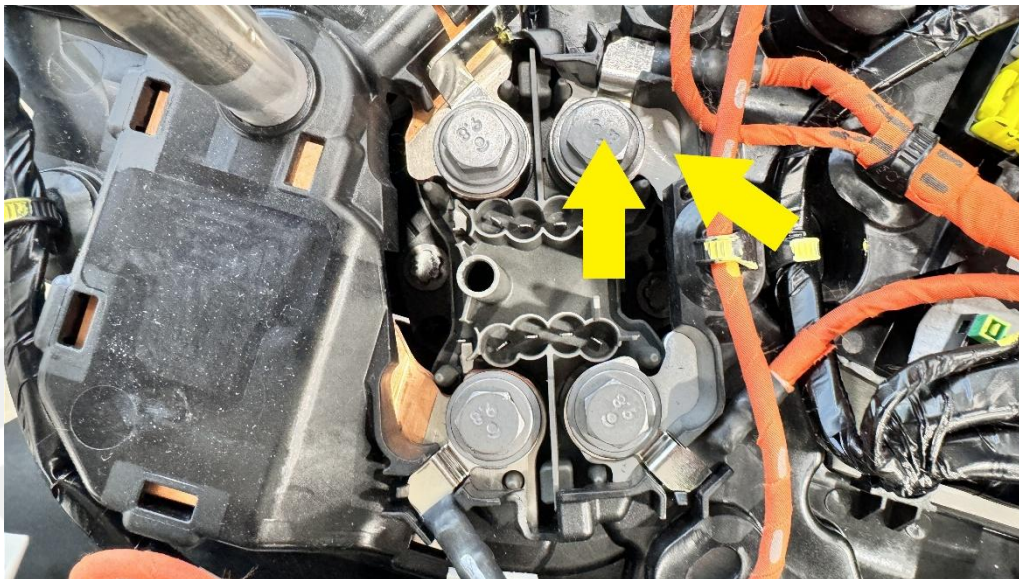
Figure 6

NOTE: The results of the measurement should be $102\mu\Omega$ or fewer. If the results are greater than $102\mu\Omega$, continue with general diagnosis outside of this bulletin.

7. Perform a zero adjust to the Hioki meter, and then perform a Hioki impedance measurement at the FC contactor negative joint to negative DC outlet busbar (Figure 6).
