Subject: UNABLE TO LOCK/UNLOCK FUEL LID AND CHARGE LID	Bulletin No.: 09-045/25
	Last Issued : 12/03/2025

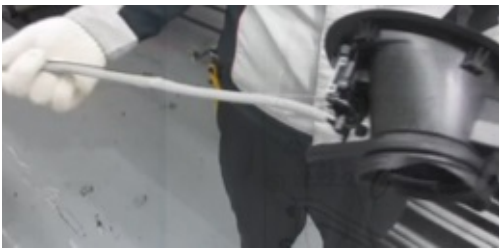
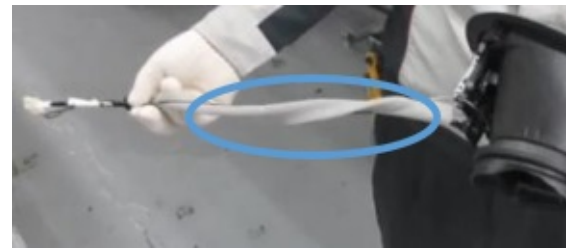
- When replacing the fuel lid actuator, ensure that the connected harness is not twisted.
- If the harness is twisted, the filler lid may not lock properly.
- For reference see images below showing correct and twisted harness conditions.

2. Replace the lid actuator with a modified one according to the instructions on MGSS.

- For PHEV models, replace the actuator on the fuel side, the charging side, or both as necessary.
- For the charging side, refer to "Lid Lock Actuator (Charging) Removal Procedure."
